# SCHEDULE OF CONSERVATION WORKS

"The Wattles"

245 Great Western Highway, South Wentworthville

October 2021

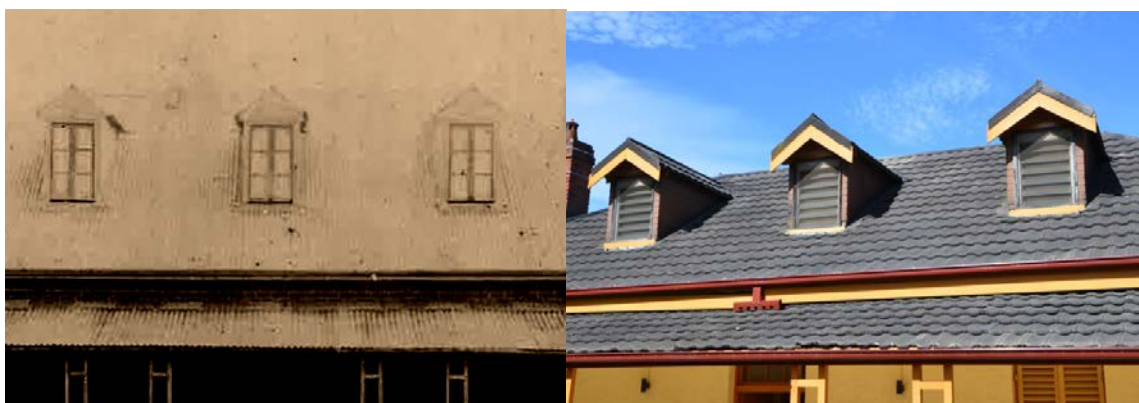
The three window sashes on the eastern side of the attic level are not original. Multi-paned window sashes in dormers that appear in early photographs have been replaced by glass louvres.

Figure 2.7 | Window sashes in the dormers, circa 1905, which were probably casement sashes. (left); louvres in dormers, 2021 (right).

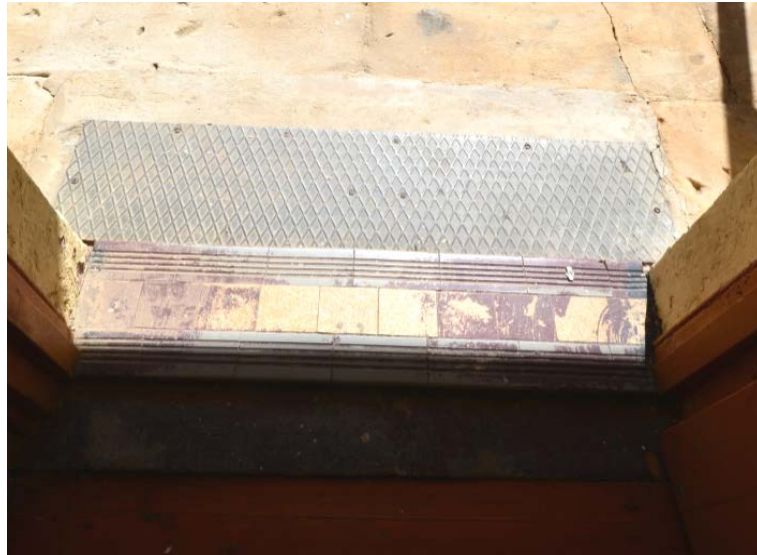
The tiled threshold at the front door appears to have been laid during the interwar period. An earlier threshold is located beneath the tiling.

**Figure 2.8 | Tiled threshold at the front door.**

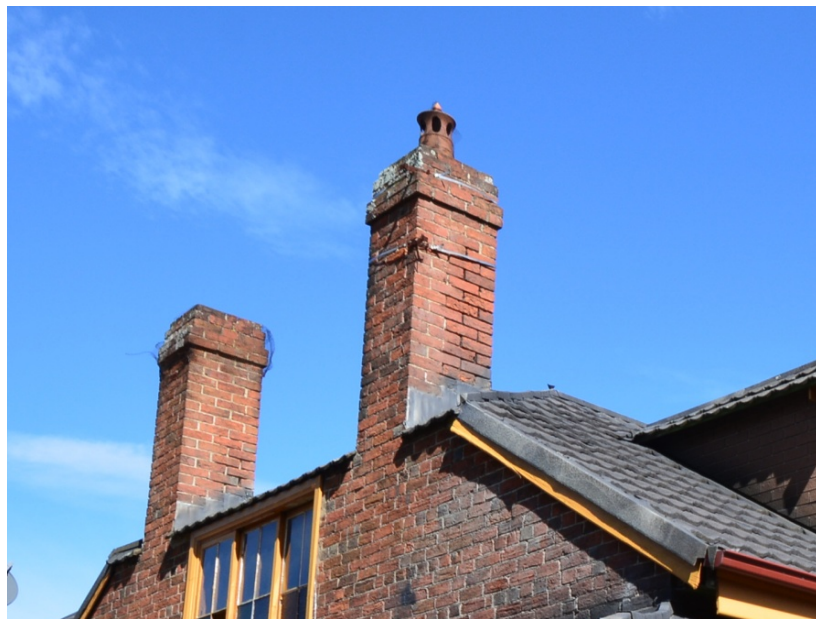
The four brick chimneys associated with the main roof and the two chimneys associated with Rooms 6 and 7 are an original part of the house. The chimneys are generally in fair condition but pointing has eroded on their western side. Metal straps have been installed the north-east chimney, which suggests that it may have needed stabilising in the past.

**Figure 2.10** | Deteriorating brick pointing in the northern chimney on the eastern side of the house.

Check chimneys are stable. carefully dismantle and relay bricks in exactly the same locations. Remove metal straps. Replace damaged bricks where the brick has deteriorated to the point where it cannot be reversed; new bricks are to match the existing bricks. Repoint brickwork where eroded using a lime mortar to match the sound mortar in the brickwork. Remove

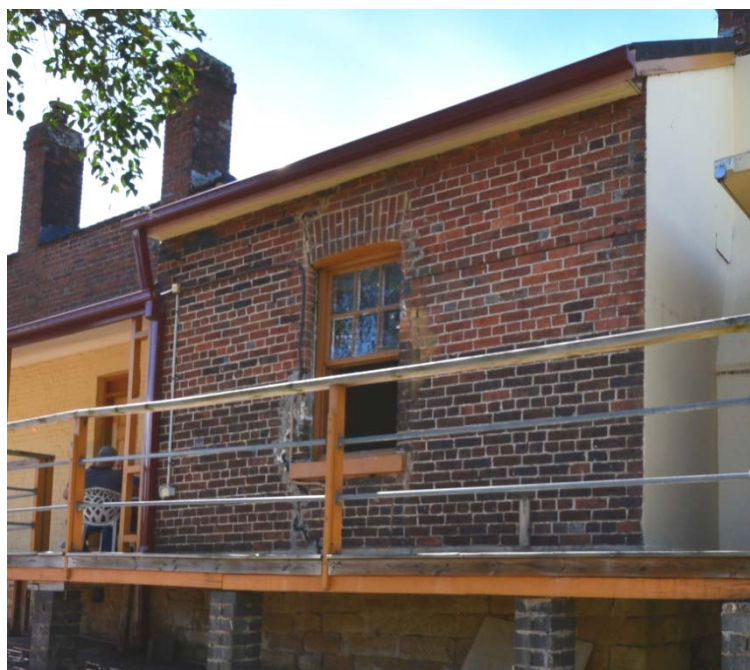
There is pronounced cracking in walls in a section of the building. The structure, including walls, footings (where practicable) and roof structure should be inspected by a suitably qualified structural engineer with recognised heritage expertise and the engineer's recommendations implemented. The recommendations should be implemented with the input of a conservation architect if they are likely to impact on significant building fabric.

**Figure 2.11** | Cracking in the western wall at the rear of the building has been an ongoing problem. Attempts to repair it in the past has been carried out crudely.

Cracking in brick walls should be inspected by a qualified structural engineer that has experience with heritage listed buildings. The advice from the structural engineer regarding works required to remedy cracking should be followed.

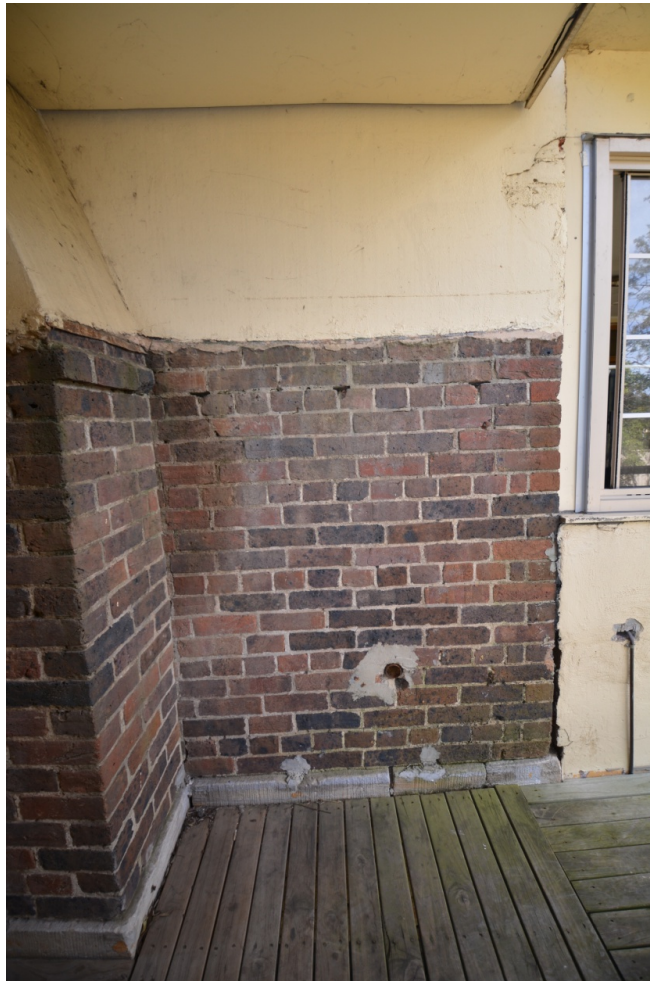
**Figure 2.12 | Brickwork on the southern side of the southern wings (Rooms 6 and 7) requires repairs to mortar, replacement of new bricks where holes have been formed and careful removal of cement patching.**

Brickwork should be repointed where necessary. This is most evident in the northern elevations of the place. Pointing and mortar repair should be undertaken using mortars to match existing mortar composition and appearance. Early mortars are generally richer in lime content and should be repointed like for like. Replacement mortar should be of a "softer" composition to allow moisture passage through the pointing instead of through brickwork.

Surface defects in brickwork can be addressed by turning existing bricks rather than replacing.

It is preferable to use salvaged bricks rather than new bricks if missing brickwork is to be reinstated.

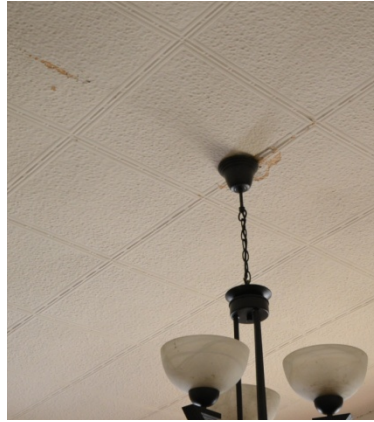
| <b>Room 7</b> | | |
|---|---|---|
| <p><b>Ceiling</b></p> | <p>Retain pressed metal ceiling. Evidence of what may be water damage around the central light fitting. If water ingress has been occurring, wiring in this part of the building must be checked. Check condition of ceiling generally</p> <p>Remove paint layers back to a sound surface and repaint.</p> | |

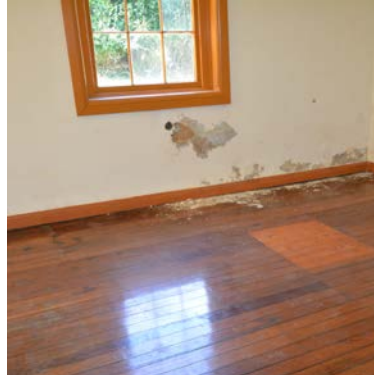
| <b>Room 7</b> | | |
|---|---|---|
| <p><b>Walls</b></p> | <p>Investigate potential causes of damp in eastern and western walls where painted surface has deteriorated. Remedy any damp using approved methodology to minimise damage to brickwork.</p> <p>Hammer tap all wall surfaces to identify drummy areas of plaster. Replace areas of unsound or damaged/cracked plaster.</p> <p>Remove paint layers back to a sound surface and repaint walls.</p> | |
