# **Heritage Inventory Sheet**

Hom Name	The Trangete Vieterian Craun				
Item Name	The Trongate Victorian Group				
Recommended Name	The Trongate Victorian Terrace Group				
Site Image					
Address	90, 92, 94, 96, 98 The Trongate, NSW 2142				
Lot/Section/DP	1 to 3		-	219451	
	A and B		-	106943	
Current LEP ID	I105 (Cumberland LEP)				
Former LEP ID	I193 (Parramatta LEP)				
Heritage Conservation Area	Not included				
Date Updated	March 2020				
Significance Level	LOCAL				
Site Type	Level 1	Built			
	Level 2	Residen	ntial buildings (private)		
Ownership	90 - Mr. Kwan So Ha Wong (19 Neich Parade, BURWOOD NSW 2134); 92 - Mr. Kon Daskalos (97 Bennalong Street, MERRYLANDS NSW 2160); 94 - Mr. Kevin Luke Hegarty (94 The Trongate, GRANVILLE NSW 2142); 96 - Mr. Antonio Jose Dos Santos Ramires (96 The Trongate, GRANVILLE NSW 2142); 98 - Mr. Steven Kenneth Orlowski, Ms Kathleen Orlowski (98 The Trongate, GRANVILLE NSW 2142); 100-102 - Mrs. Christina Kathleen Jenson, Mr Robert John Jenson (102 The Trongate, GRANVILLE NSW 2142)

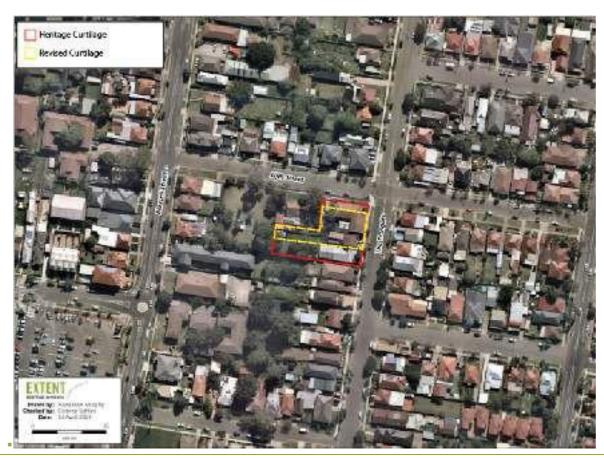
It is recommended that the heritage curtilage for I193 (Parramatta LEP) is revised as shown below due to the different styles of the dwellings. It is most appropriate to separate the site into two heritage listings including the single storey semi-detached cottage (No.100 and No.102), and the group of Victorian terraces (No.90, No.92, and No.94 No.98 and No.96). This listing sheet has been updated to reflect this recommendation. Please see I107 (Cumberland LEP) for the 'Victorian Semi-Detached cottage'. The noted Lot/DP for this listing sheet is accurate and reflects this revised curtilage.
