## Heritage Inventory Sheet

<b>Item Name</b>	Auburn Signal Box		
<b>Recommended Name</b>	Auburn Railway Signal Box		
<b>Site Image</b>

<b>Address</b>	Rawson Street, opposite Karrabah Road, Auburn NSW 2144		
<b>Lot/Section/DP</b>	Part Lot 3803	-	1168594
<b>Current LEP ID</b>	A01023 (Cumberland LEP)		
<b>Former LEP ID</b>	A01023 (Auburn LEP)		
<b>Heritage Conservation Area</b>	Not included		
<b>Date Updated</b>	March 2020		
<b>Significance Level</b>	STATE		
<b>Site Type</b>	Level 1	Built	
	Level 2	Transport - Rail	
<b>Ownership</b>	Transport Asset Holding Entity Of NSW

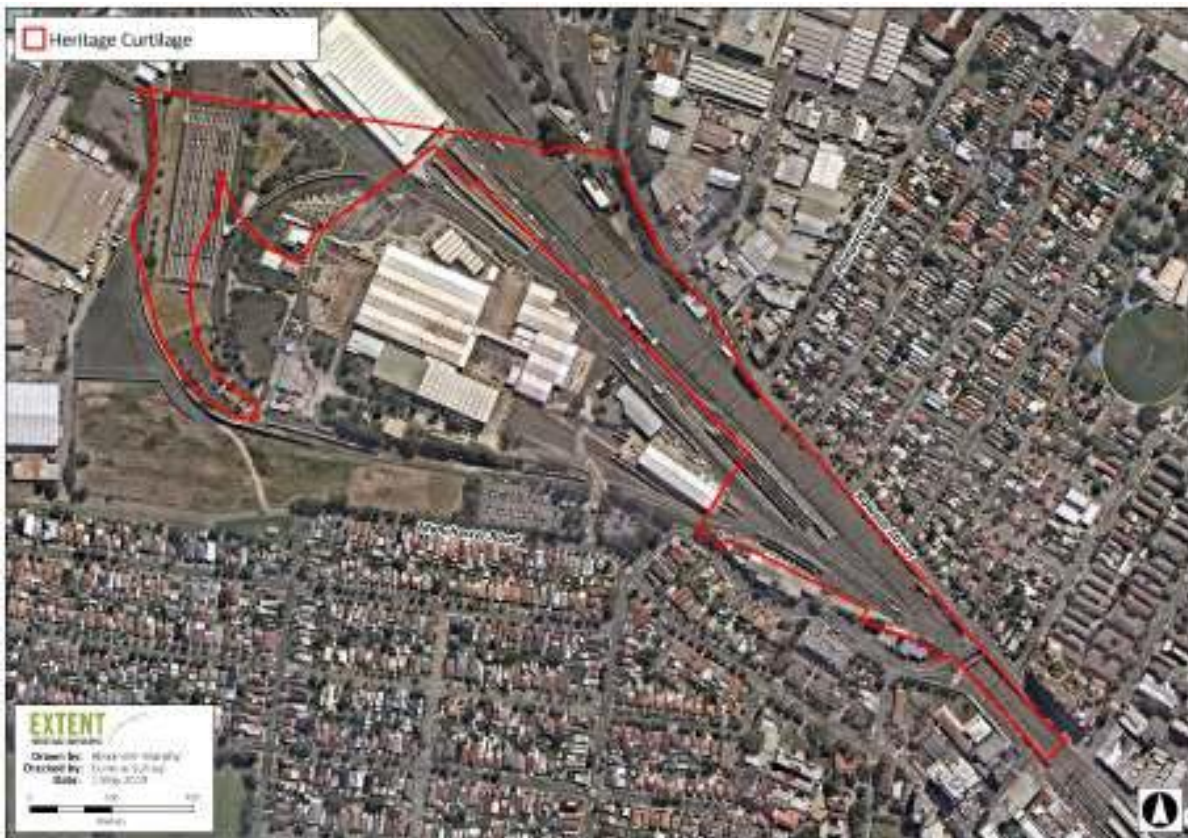
## Curtilage Map

**Revised curtilage recommended- refer below.**

- The item should be renamed to 'Auburn Railway Signal Box' to match the State Heritage Register listing for the item.
- The heritage curtilage should be revised to match the State Heritage Register curtilage for the item, shown below.
- Should the revised curtilage be adopted, this listing sheet does not reflect the current Lot/DP which will need to be altered.

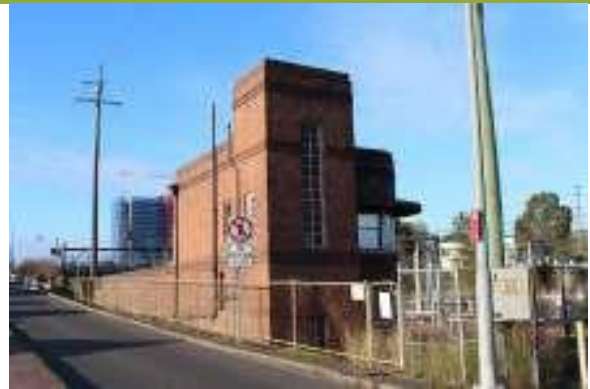
View to north-western and north-eastern elevations of Signal Box

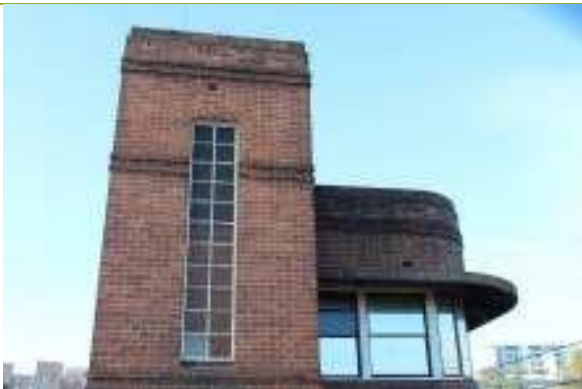
Detail of north-western elevation of Signal Box.

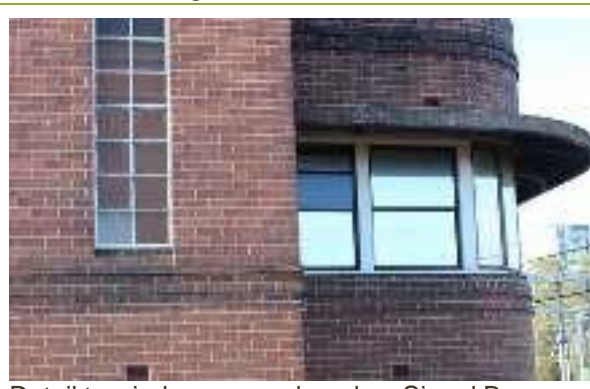
- 1981: Air conditioning installed in Signal Box upper level
- c1985: Some of the Signal Box window frames removed and replaced with modern materials and brick relay room annex added to Signal Box

Detail to windows as replaced on Signal Box.
