Heritage Inventory Sheet

Item Name	Horse Trough		
Recommended Name	Horse Trough		
Site Image

Address	Corner of Water Street and Auburn Road, Auburn NSW 2144		
Lot/Section/DP	-	-	-
Current LEP ID	I20 (Cumberland LEP)		
Former LEP ID	I13 (Auburn LEP)		
Heritage Conservation Area	Not included		
Date Updated	March 2020		
Significance Level	LOCAL		
Site Type	Level 1	Movable/Collection	
	Level 2	Farming/Grazing

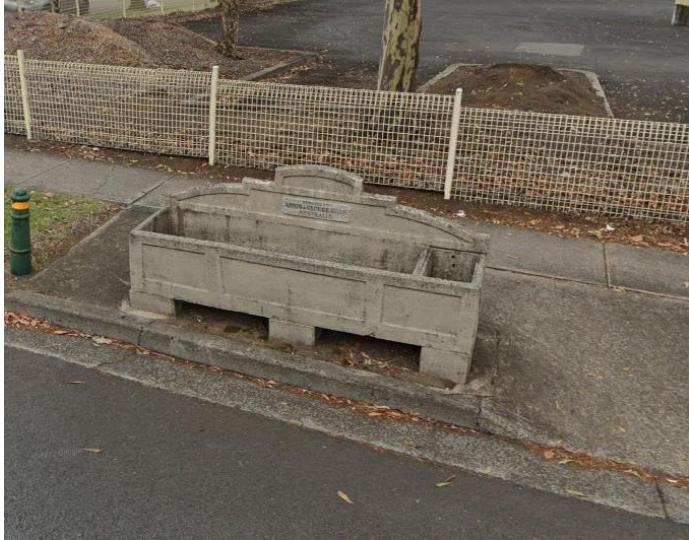
The item is a precast concrete horse trough with internal steel reinforcing. The trough is divided into two compartments, one substantially larger than the other. The concrete uses a large dark bluestone aggregate throughout the trough with the exception of the name plate which has a fine white stone aggregate inserted, giving it some visual prominence. Engraved into this name plate is "DONATED BY / ANNIS & GEORGE BILLS / AUSTRALIA". The engraved letters are painted black.

The trough itself is formed of one piece of precast concrete, with the decorative rounded backing pediment attached as a separate piece, as are the three blocks which form the feet of the trough. There is a steel ring that protrudes from the front edge of the trough, which would have been used to tether horses.

The trough is positioned on the northern verge of Water Street, on the corner of Auburn Street. A concrete pad, footpaths and street kerbing are all positioned closely, or abutting, the trough.

The condition of the trough is good, although it does exhibit signs of weathering and expected wear and tear. The embossing profile around the edges of the back pediment and around the trough is no longer pronounced, and some exposed metal reinforcing is corroding. It does not show any signs of impact damage despite its proximity to the roadway.

- The item is at a high risk of damage by motor vehicles, as this intersection is highly trafficked. Relocation to a more appropriate location (for example, in a 'No Stopping Zone') along Water Street may be a good outcome.
- As the listing concerns the horse trough only, the heritage curtilage shown below should be considered as a revised curtilage for the new Cumberland LEP.
- Should the revised curtilage be adopted, this listing sheet does not reflect the current Lot/DP which will need to be altered.
