Heritage Inventory Sheet

Item Name	Former Farm, Hyland Road Inn and former post office (also House and Farm buildings)
Recommended Name	Former Hyland Road Inn, Farm and Post Office

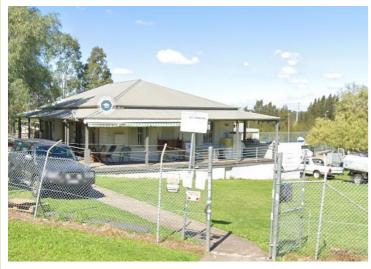
Site Image

The subject site is a large agricultural property, which is uncommon for the highly suburbanised area. The site contains a weatherboard residence fronting Hyland Road. The house has a modern replacement corrugated steel roof and has been fully reclad in new weatherboard. There is a wrap-around verandah on all sides of the house with a corrugated steel sheet roof at the same pitch as the main roof, and timber deck which also appears to be replacement material. The verandah is supported by simple timber posts. The southern corner of the house is raised on an enclosed masonry base. There are a number of modern accretions evident on the façade including security screens, a modern balustrade fixed to the verandah timber posts, electrical boxes, lighting, etc. The house has a detached demountable building to rear east corner connected via the verandah.

To the south is a brick gabled outbuilding with an attached gable-roofed extension, possibly a dairy with milking shed. Additional farm equipment can also be found to the south of shed. There is a tennis court in the rear southeast corner of the site.

The condition of the built elements on site is fair overall.
