Heritage Inventory Sheet

Item Name	Federation Period Cottage		
Recommended Name	Federation Cottage		
Site Image

Address	33 Walker Street, Merrylands NSW 2160		
Lot/Section/DP	1-2	-	1138261
Current LEP ID	I219 (Cumberland LEP)		
Former LEP ID	I79 (Holroyd LEP)		
Heritage Conservation Area	Not included		
Date Updated	March 2020		
Significance Level	LOCAL		
Site Type	Level 1	Built	
	Level 2	Residential Buildings (private)

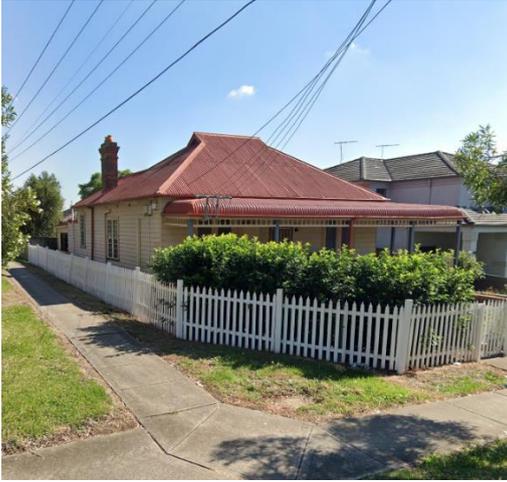
The subject building is a single storey Federation cottage. The item is clad with rusticated weatherboards, and has a half gabled and hipped roof clad in corrugated iron. The verandah is open and L-shaped, and extends around the north-east corner. It has a bullnose roof clad in red Colorbond sheeting and is supported on simple timber posts with a timber frieze and simple timber slat balustrading. A number of steps with terrazzo treads lead up to the verandah timber floor which rests on brick infill footings. The front facade of the building features a central panelled door framed by two pairs of multipaned double hung windows with security screens. A portion of the northern verandah has been infilled and clad in Fibrous Cement sheeting. It adjoins a skillion roofed section. The main roof changes pitch and extends over the rear of the house, which also features a hipped roof wing and skillion roofed addition in the southern section of the house. The southern wing also features a face brick profiled chimney with two terracotta pots. The facades feature timber framed double hung sash windows with flyscreens attached to the lower sash and a security frame over the opening.

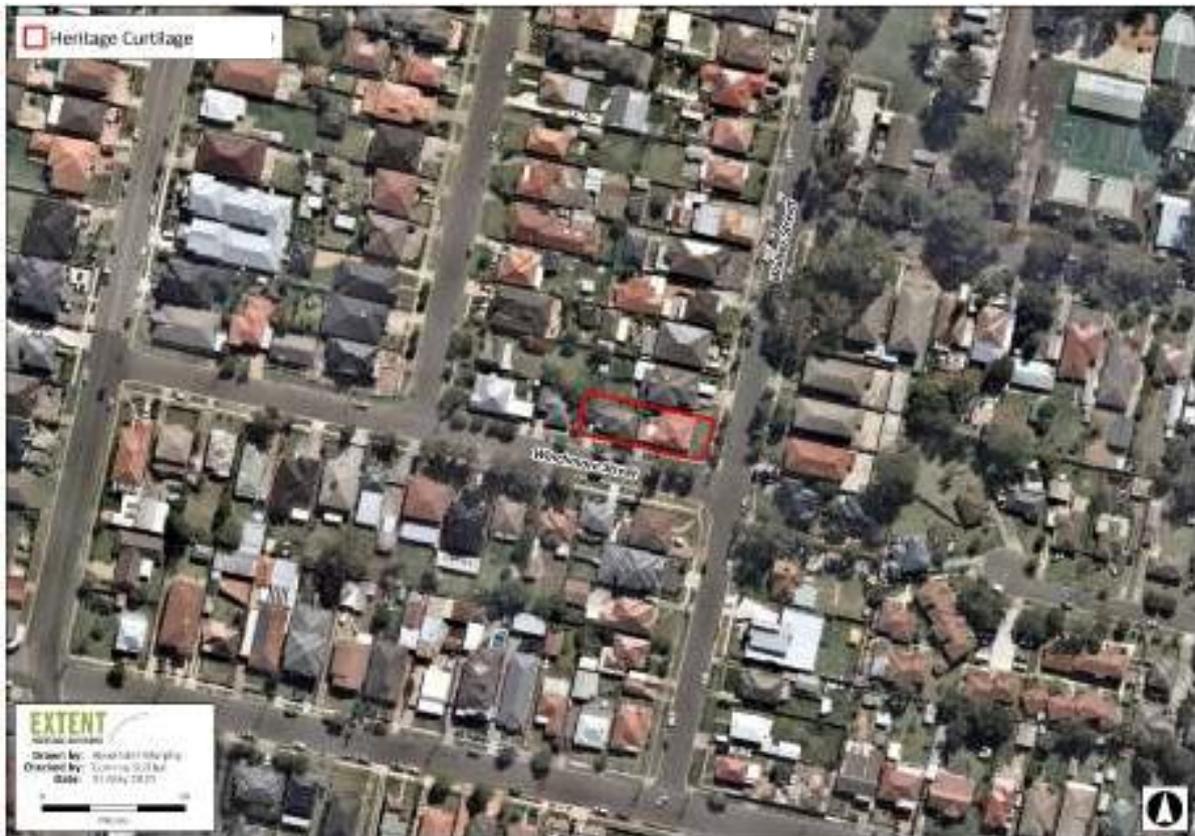
Curtilage Map

Revised curtilage recommended - refer below.

- As the western portion of the current site now includes a modern dwelling of no heritage value, the heritage curtilage shown below should be considered as a revised curtilage for the new Cumberland LEP. Should the revised curtilage be adopted, this listing sheet does not reflect the current Lot/DP which will need to be altered.

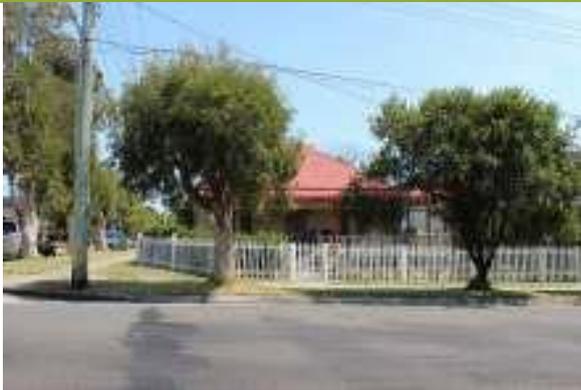
The cottage is set back from the street and is situated on a deep corner block. The property has a painted white timber picket fence along the front boundary and some hedging. While the property does not contain any significant plantings within its curtilage, the street trees are a prominent and aesthetic feature of the streetscape that contribute to the aesthetic of the residence.

Overview of cottage from Walker Street.

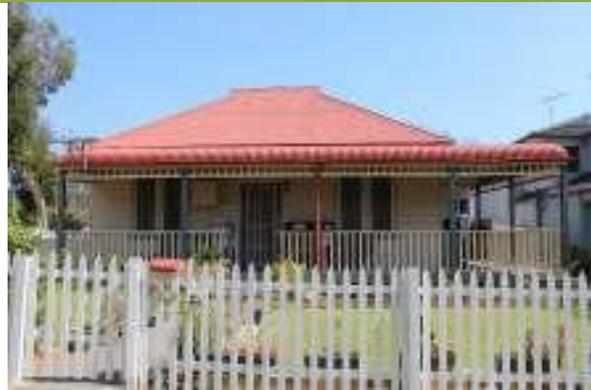
- All timber elements of the verandah have been stripped, primed and repainted. Timber posts likely replaced
- New verandah roof clad in Colorbond sheeting
- The roof shows some wear and is poorly maintained
- Rear additions with the inclusion of various cladding materials that may be a result of an application to convert the house into two flats made in 1964
- The Fibrous Cement infill on the northern verandah features a doorway*

Front façade of cottage.

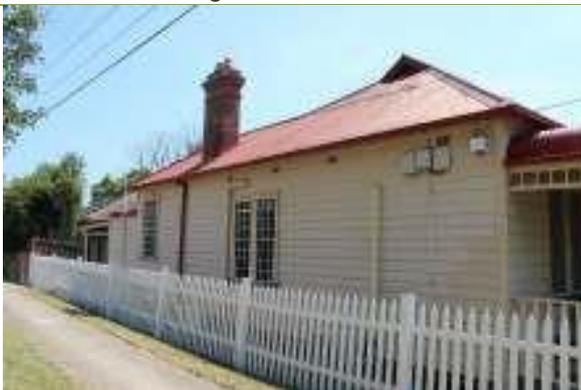
Southern elevation of cottage on Winchmore Street.

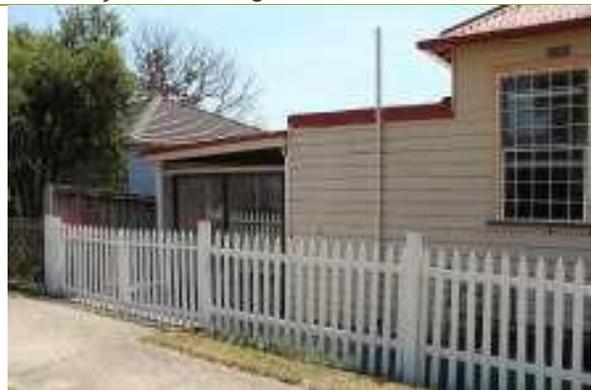
View to rear of cottage.

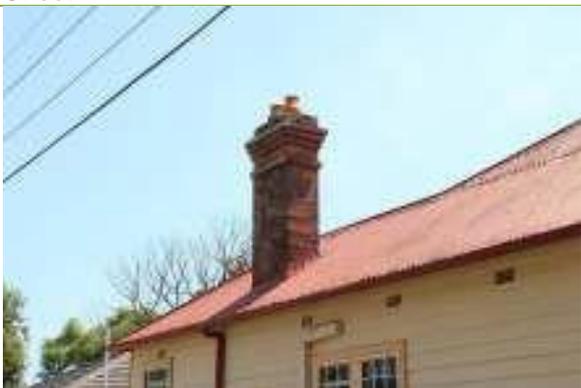
The condition of the building is considered to be fair. The main roof shows signs of wear and the chimney brickwork has some biological growth on the southern elevation.

View to chimney on southern elevation of cottage.
