# Heritage Inventory Sheet

<b>Item Name</b>	Houses Built for Housing Commission		
<b>Recommended Name</b>	Chiswick Road Houses Built for Housing Commission		
<b>Site Image</b>

<b>Address</b>	27, 29, 33, 35, 37, 39, 41, 43 and 47 Chiswick Road, South Granville, NSW 2142		
<b>Lot/Section/DP</b>	39, 41-46 and 48-50	-	35007
<b>Current LEP ID</b>	I237 (Cumberland LEP)		
<b>Former LEP ID</b>	I603 (Parramatta LEP)		
<b>Heritage Conservation Area</b>	Included, Blaxcell Estate Conservation Area		
<b>Date Updated</b>	March 2020		
<b>Significance Level</b>	LOCAL		
<b>Site Type</b>	Level 1	Built	
	Level 2	Residential Buildings (private)

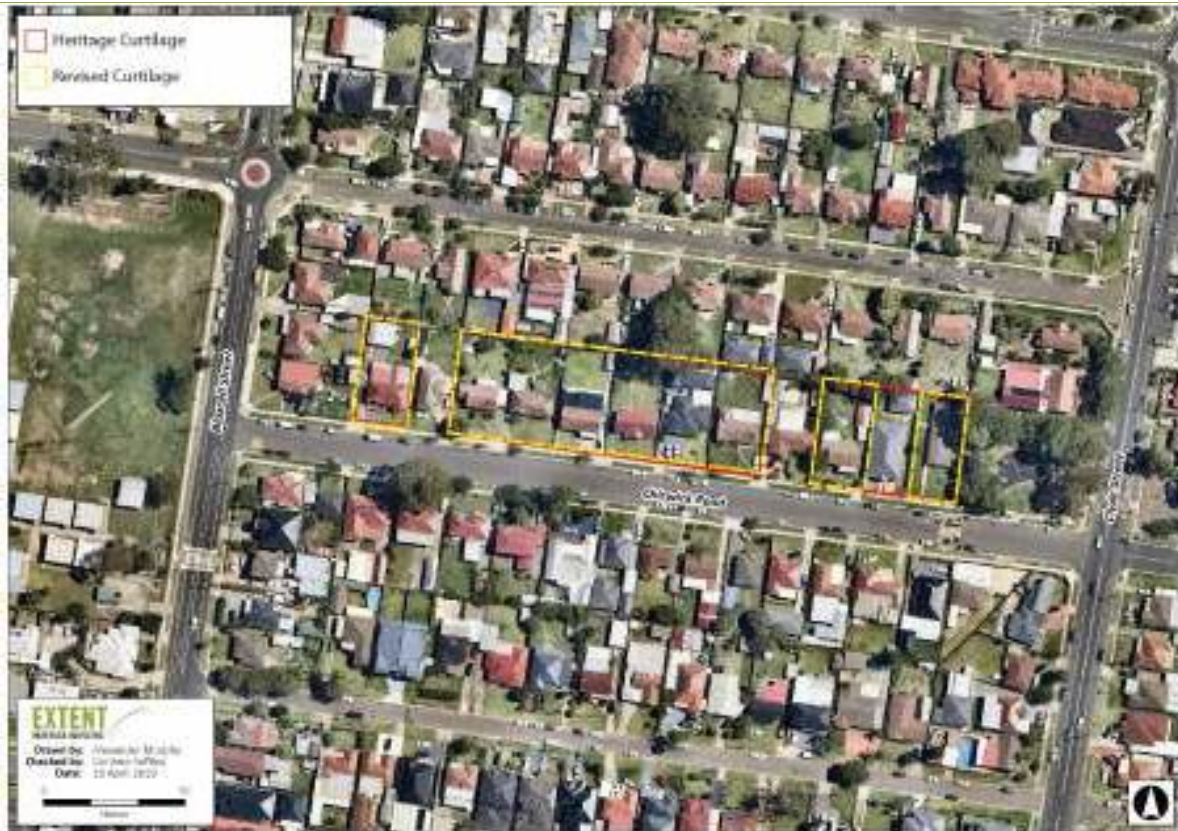
- A new dwelling has been constructed at 27 Chiswick Road, adjacent to an original but highly modified Housing Commission dwelling. The heritage curtilage shown below should be considered as a revised curtilage for the Cumberland LEP. Should the revised curtilage be adopted, this listing sheet does not reflect the current Lot/DP which will need to be altered.

5. The heritage curtilage for this item should be revised/reduced.	X	10. Maintain the historic aesthetic/character of the item and area (e.g. paint scheme, materiality, style, landscape elements).	X

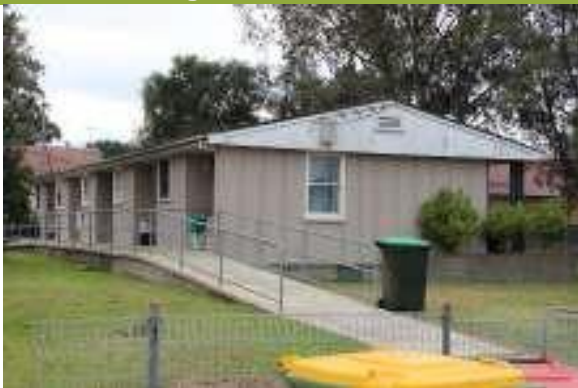
No. 27 Chiswick Road.

The building at 27 Chiswick Road is unlike any of the other housing commission dwellings on the street. This single-storey building includes four separate apartments, orientated to the east and addressing the park adjacent to the site rather than Chiswick Road. The building includes a cement tile gable roof timber with vertical timber boards to the gable end, double-hung sash windows, fibro sheeting walls, concrete steps (some of which have been tiled) and unornamented timber doors with modern flyscreens. The building has been modified with the inclusion of a large concrete ramp along the western elevation, set on top of a brick base. The ramp includes a painted steel balustrade. Due to the style of the building, it is likely that it was constructed at a later date than the other commissioning housing dwellings on the street.

A modern, single-storey brick dwelling is currently under constructed on the site, between the original dwelling and 29 Chiswick Road.

The dwelling is in a good condition.

- Modern dwelling constructed on site\*
- Integrity = Nil

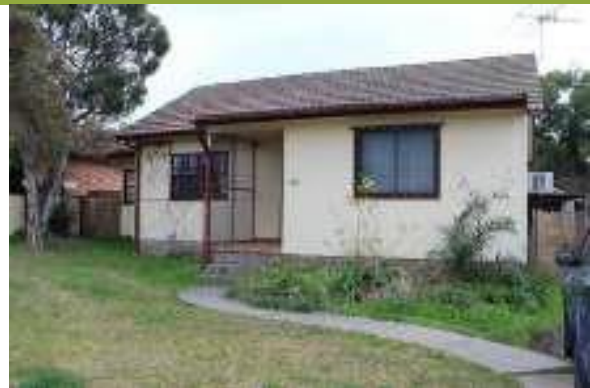
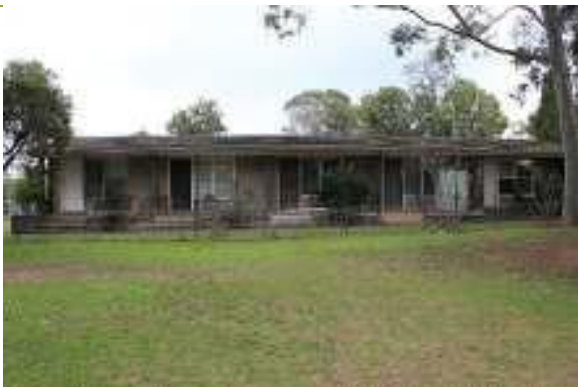
No. 29 Chiswick Road.

The dwelling has been built on a brick base, with fibro sheet walls and a cement tiled gabled roof with cement tile ridge capping. Windows are timber double hung with flyscreens and four long panes of glass to each. One window on the eastern (side) elevation has a mounted air conditioning unit. The porch is tiled and has been partially enclosed with fibro sheeting and two large sections of clear acrylic. The porch is sheltered by a flat Corrugated iron roof and is entered via three stairs which lead from the footpath. The dwelling has a small, single-storey extension with a flat roof.

The concrete footpath leads from a concrete driveway which runs along the eastern boundary of the site. There are several established trees in the front yard, though it is largely a grassed area. There is no front boundary fence.

The dwelling is in a good condition.

- Air-conditioning unit in window\*
- Tiled porch
- Partially enclosed porch\*
- Single-storey extension to the rear
- Integrity = Moderate

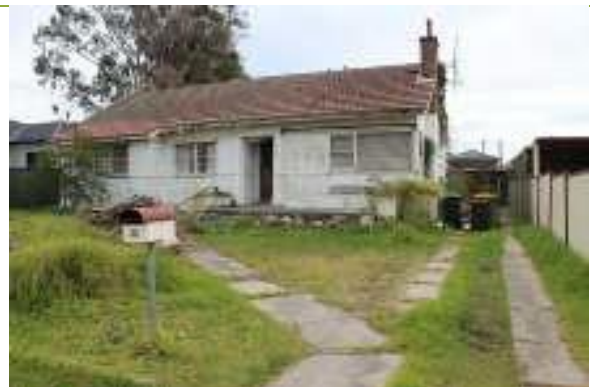
No. 33 Chiswick Road.

The dwelling has been built on a brick base, with fibro sheet walls and a cement tiled gabled roof with cement tile ridge capping. There is a single face brick chimney to the eastern side of the roof. Windows are timber double hung with flyscreens and four long panes of glass to each. There is no covered porch, though the front entrance is located just inside an enclave. The dwelling has been extended to the rear with a single-storey flat roof structure.

The front yard is not well maintained, with overgrown grass and tree cuttings. Two circular, painted brick garden beds are located on either side of the entrance, containing overgrown plantings. There are several established trees adjacent to the street which screen views of the building. There is no front boundary fence.

The dwelling is in a fair condition, with some elements such as the fibro noted to be in poor condition.

- Single-storey extension to the rear
- Integrity = High

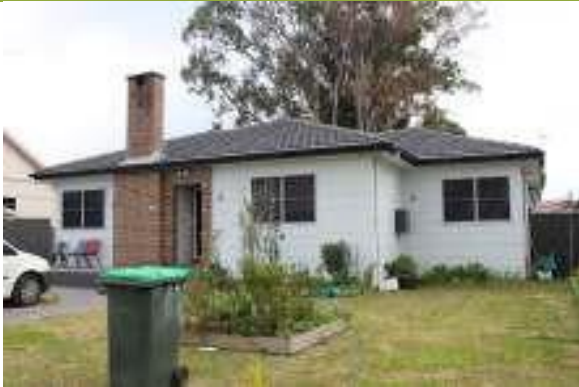
No. 35 Chiswick Road.

The dwelling has been built on a brick base, with aluminium clad walls to imitate wide weatherboards and a modern tiled hipped roof. The roof also has a new guttering system. There is a single face brick chimney to the front of the roof, with a chimney breast visible down the front elevation that has been recently repointed. It is unclear if the timber windows are extant as they are now covered by modern fly screens with aluminium framing. There is no covered porch, although the front entrance is located just inside a brick enclave that appears to have been recently repointed. The dwelling has been extended to the rear with a single-storey flat roof structure. It appears as though a granny flat has also been added to the rear yard.

The front yard is well maintained. There are no established plantings though the front yard contains several small garden beds. There is no front boundary fence.

The dwelling is in a good condition, having undergone renovations recently.

- Aluminium clad walls to imitate wide weatherboards\*
- Replaced roof and guttering
- Repointed brickwork
- Aluminium framed flyscreens to the outside\*
- Single-storey extension to the rear
- Granny flat to the rear
- Recent garden beds to the front yard
- Integrity = Moderate

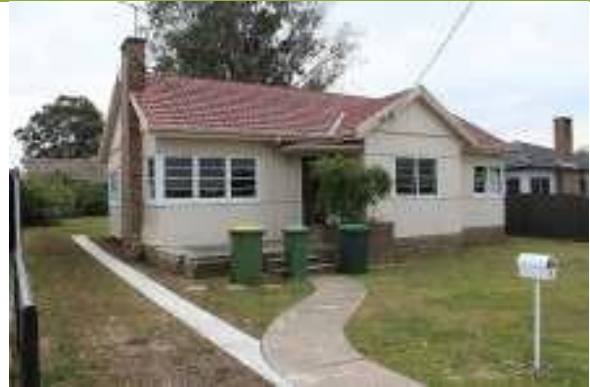
No. 37 Chiswick Road.

The dwelling has been built on a brick base, with fibro sheet walls and a terracotta tiled gabled roof with a projecting gable to the front. There is a single face brick chimney to the western side of the roof and the chimney breast is visible down the western elevation. Windows are timber double hung, with four long panes of glass to each. There is a concrete porch next to the front door, partially covered by a circular awning. The dwelling has not been extended to the rear.

The front yard is well maintained grass with a concrete footpath leading to the front door. There are no established plantings. There is no front boundary fence.

The dwelling is in a good condition.

- None
- Integrity = High

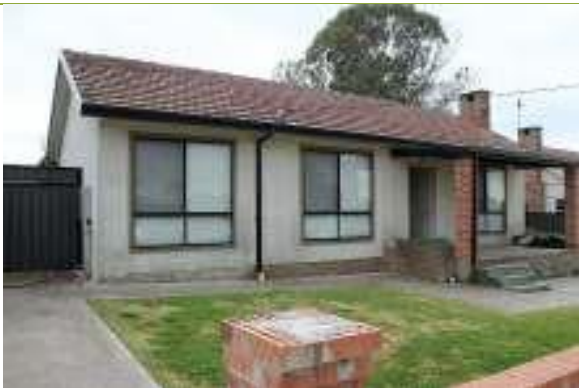
No. 39 Chiswick Road.

The dwelling has been built on a brick base, with fibro sheet walls and a cement tile gabled roof. There is a single face brick chimney to the eastern side of the roof and the chimney breast is visible down the western elevation. The original timber windows to the front facade have been replaced with three large aluminium frames which is disproportionate to the scale of the dwelling. The front porch is set on a brick base with a concrete topping. The porch is covered by a recent flat roof awning set on two brick piers. The dwelling has been extended to the rear with a large flat-roof extension which is a similar size to the original dwelling.

The front yard is well maintained grass with a concrete footpath leading to the front door. There are no established plantings. Unlike most dwellings along the northern side of Chiswick Road, the site has a face brick boundary wall.

The dwelling is in a good condition.

- Timber windows replaced with large aluminium framed windows to façade\*
- Flat roof awning to porch\*
- Large single-storey extension to the rear
- Integrity = Moderate

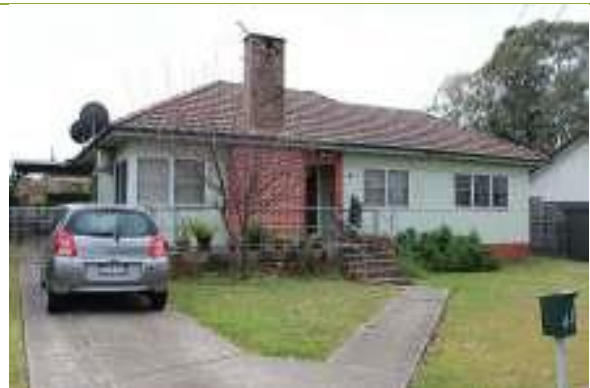
No. 41 Chiswick Road.

The dwelling has been built on a brick base, with fibro walls and a cement tile hipped roof. There is a single face brick chimney to the front of the roof, with a chimney breast visible down the front elevation. The chimney breast appears to have been cleaned and repointed recently, otherwise the brick has been replaced. Windows are timber double hung with aluminium framed flyscreens and four long panes of glass to each window. There is no covered porch, though the front entrance is located just inside a brick enclave. The dwelling has not been extended to the rear.

The front yard is well maintained. There are no established plantings though the front yard contains a garden bed which runs along the front of the building. There is no front boundary fence.

The dwelling is in a good condition.

- Aluminium framed flyscreens to the outside\*
- Repointing or reconstruction of chimney breast to the front façade
- Integrity = High

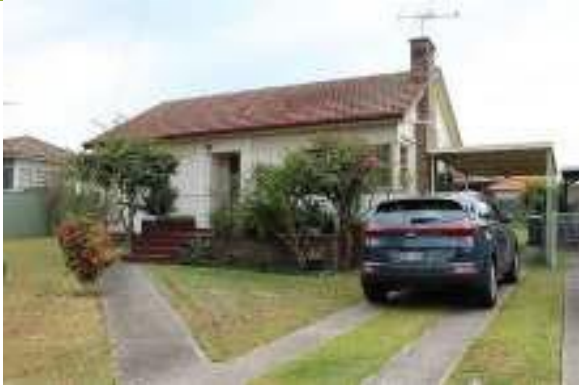
No. 43 Chiswick Road.

The dwelling has been built on a brick base, with fibro walls and a cement tile gable roof. There is a single face brick chimney to the eastern side of the roof and the chimney breast is visible down the eastern elevation. Windows are timber double hung with aluminium framed flyscreens and four long panes of glass to each window. There is no covered porch, though the front entrance is located just inside an enclave. The dwelling has been extended to the rear with a single-storey, flat roof addition.

The front yard is well maintained. There are several young trees in the front yard as well as a garden bed directly in front of the dwelling. There is no front boundary fence.

The dwelling is in a good condition.

- Aluminium framed flyscreens to the outside\*
- Single-storey rear extension
- Integrity = High

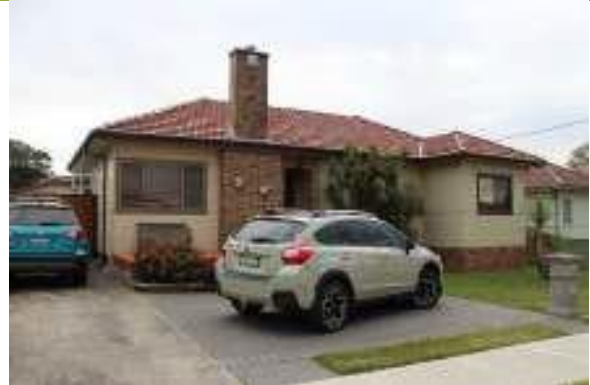
No. 47 Chiswick Road.

The dwelling has been built on a brick base, with fibro walls and a cement tile hipped roof. There is a single face brick chimney to the front of the roof, with a chimney breast visible down the front elevation. Timber windows have been replaced with wide aluminium framed windows. There is no covered porch, though the front entrance is located just inside a brick enclave. There is a set of five tiled stairs leading up to the front entrance with a simple steel balustrade. The dwelling has been extended several times to the rear. A large granny flat or shed has also been added to the rear north west corner of the site.

The front yard is well maintained. There are no established plantings though the front yard contains a garden bed which runs along the front of the building. There is no front boundary fence.

The dwelling is in a good condition.

- Aluminium windows\*
- Several single-storey extensions to the rear
- Granny flat or shed in north west corner
- Integrity = Moderate
