Heritage Inventory Sheet

Recommended Name	St Aphanasius Ukrainian Orthodox Church and Hall		
Site Image	 		
Address	45 William Street, Granville NSW 2142		
Lot/Section/DP	1	-	521491
Heritage Study ID	HS48		
LEP ID	Not currently included on the Cumberland LEP		
Heritage Conservation Area	Not included		
Date Updated	February 2021		
Significance Level	LOCAL		
Site Type	Level 1	Built	
	Level 2	Religion

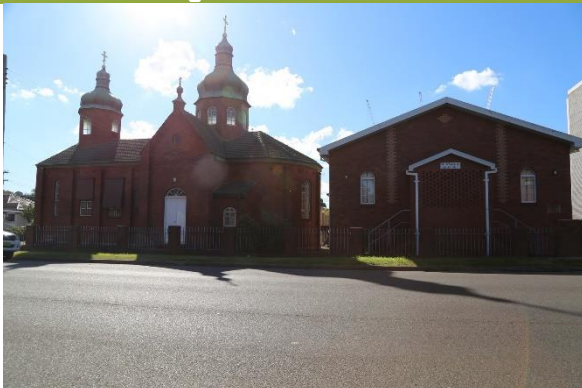
St. Aphanasius Memorial Hall is located towards the rear of the Church. It is a simple face-brick hall with polychromatic brick detail and a gabled roof. The roof material was not visible on inspection. The Hall is sympathetic in design with the Church and features segmented arch headed windows along all elevations. Along the lower half of the walls there are long vertical elaborate metal vents. The facade to William Street features a front entrance to the Hall which is concealed by a projecting gable with brick screen wall and is accessed on either side by concrete steps with metal railing. A metal foundation and memorial plaque is fixed to the façade.

Overview of Church and Hall along William Street.

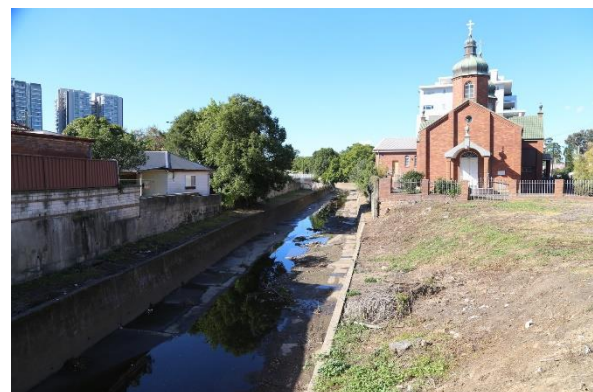
The Church and Hall have a unique, prominent siting, situated directly alongside Duck Creek canal. The Church has been built to front Enid Street and has an unusually deep setback from this street. It

Church as it sits alongside Duck Creek Canal.

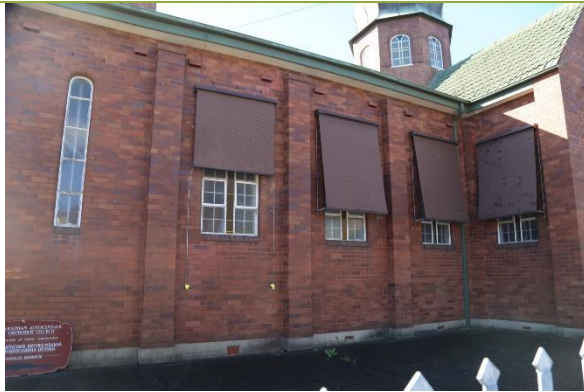
There are tall segmented arch headed windows along the side elevations to which some windows have metal retracting awnings attached. A side entrance via to the Church is visible along William Street which consists of a diagonal timber double door painted white with segmented arch transom light. This entrance is accessed by a concrete ramp with metal railing.

Side of Church along William Street.

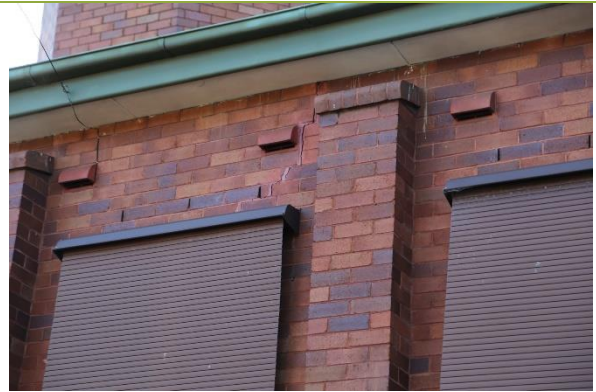
Overall, the Church and Hall are well-maintained and are in a good condition. There is some brick cracking along the side wall of the Church.

Detail of cracking to Church wall.

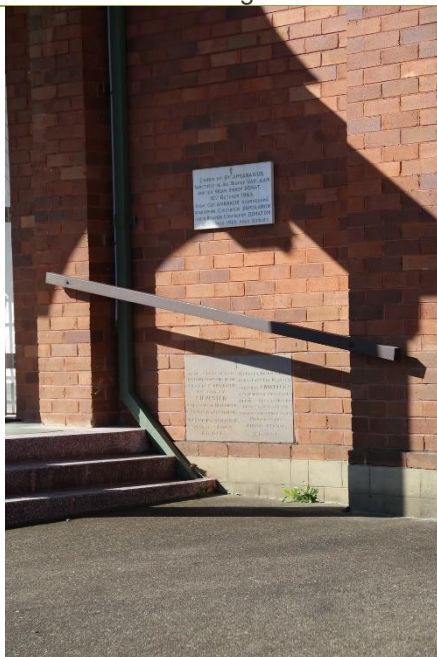
Plaques on façade of Church.

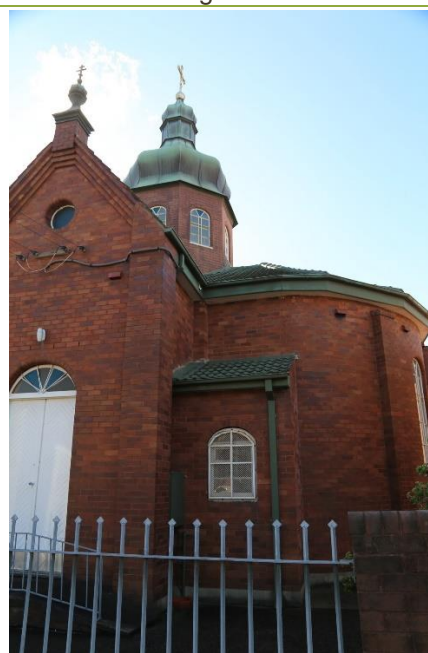
The façade of the Church features a forward facing gable with four subtle brick pilasters and bullseye window with fixed glazing at the centre of the gable. The entrance portico is a structure of a timber panelled arched roof sheeted in copper supported on brick columns with bullnosed corners. The entrance is accessed by three pebblecrete steps which lead to a tessellated tiled floor. The front entrance door is a diagonal timber double door painted white and with a metal security door attached to it and segmented arch transom light. Two foundation plaques are inset into the façade wall.

Detail of Church façade.

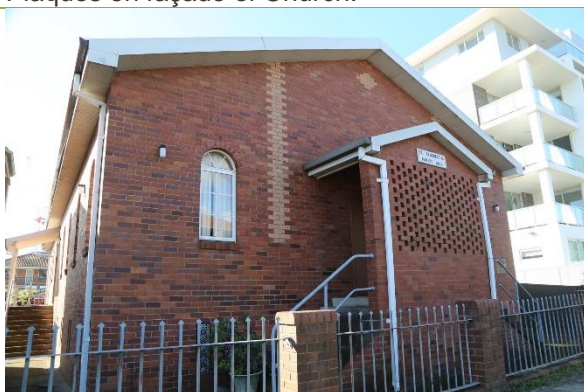
Hall.

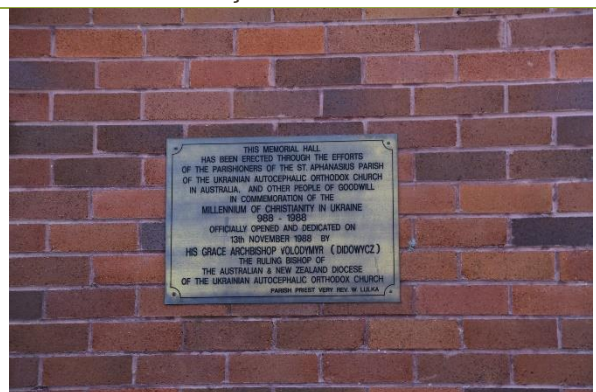
Foundation plaque on Hall.
