Heritage Inventory Sheet

Recommended Name	Former Auburn Post Office		
Site Image	 		
Address	4 and 4A Auburn Road and Kerr Parade, Auburn, NSW 2144		
Lot/Section/DP	1	-	455487
	1	-	434432
	1	-	119916
Heritage Study ID	HS2		
LEP ID	Not currently included in the Cumberland LEP		
Heritage Conservation Area	Not included		
Date Updated	January 2021		
Significance Level	LOCAL		
Site Type	Level 1	Built	
	Level 2	Postal and Telecommunications

Former Auburn Post Office

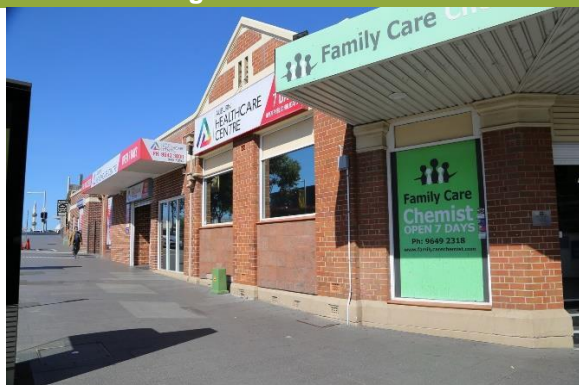
View along elevation fronting Kerr Street.

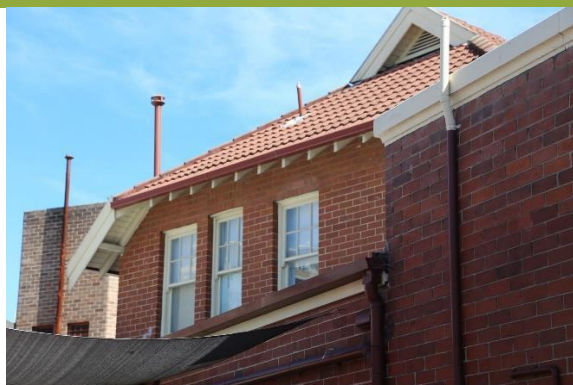
A highly intact upper storey with terracotta tiled dutch-gabled roof sits in the center of the building and is stepped back from the ground floor parapet. This section features prominent eaves, exposed rafter and original sash windows.

View to upper level of post office.

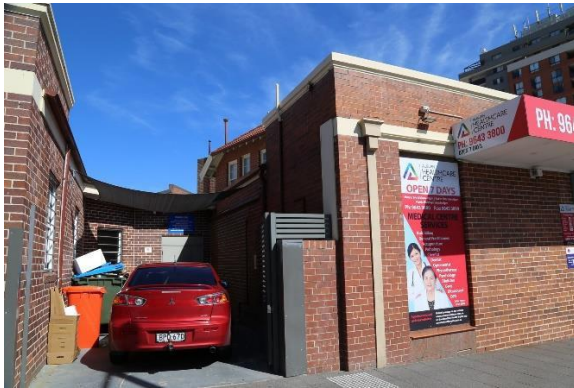
The building was extended in the c.1960s along Kerr Parade and Auburn Road and featured a brick verandah along Kerr Parade. The Post Office was again extended more recently and features a modern driveway and access gate. Auburn Post Office is surrounded by paved pedestrian footpath along which there are three palm trees and hedging along Auburn Road.

View to rear of Post Office along Kerr parade showing rear extension.

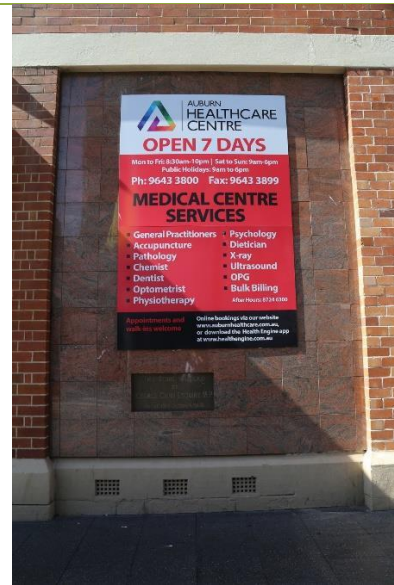
The ground level of the building has been highly modified and is less legible architecturally than the upper storey. The front entrance consists of an infilled porch which consisted of four brick plinths with corbelled sandstone capping. The entrance now has a modern metal roller door flanked by two metal framed single paned windows. Original windows have been replaced with modern single paned glazed windows with metal framing and terracotta sills or have been infilled with glazed tiling. Original terracotta vents (some of which are damaged) are located along the sandstone footing. Modern signage and modern awnings used on the building detract from the overall aesthetic value of the building. A stone plaque is inset into a tiled wall behind the tiled wall along Auburn Parade. It reads:

Overview of stone wall with foundation stone inset at the lower section.

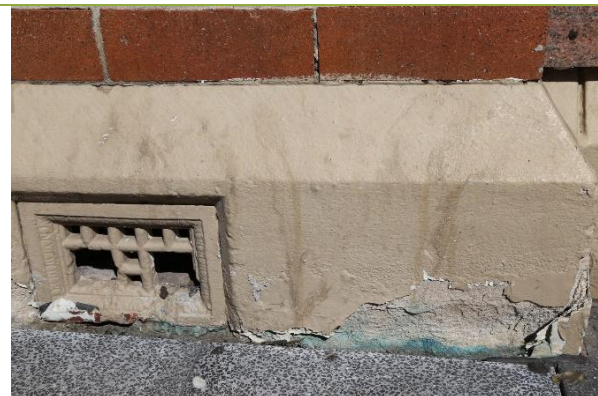
Overall, the building is in a good condition except for some damaged terracotta vents and the delamination of the sandstone due to the use of acrylic paint as render.

Detail to damage caused to sandstone footings by acrylic paint. Not also damage to vent.

- The façade of the Auburn Post Office has been heavily modified. Should the opportunity arise, it is highly recommended that the contemporary signage on the facade, including the awnings should be removed from the façade and more sensitive heritage options investigated.
- It is highly recommended that the delaminated sandstone be conserved by a skilled heritage tradesperson. Acrylic paint should not be used on sandstone, and this should be rectified.

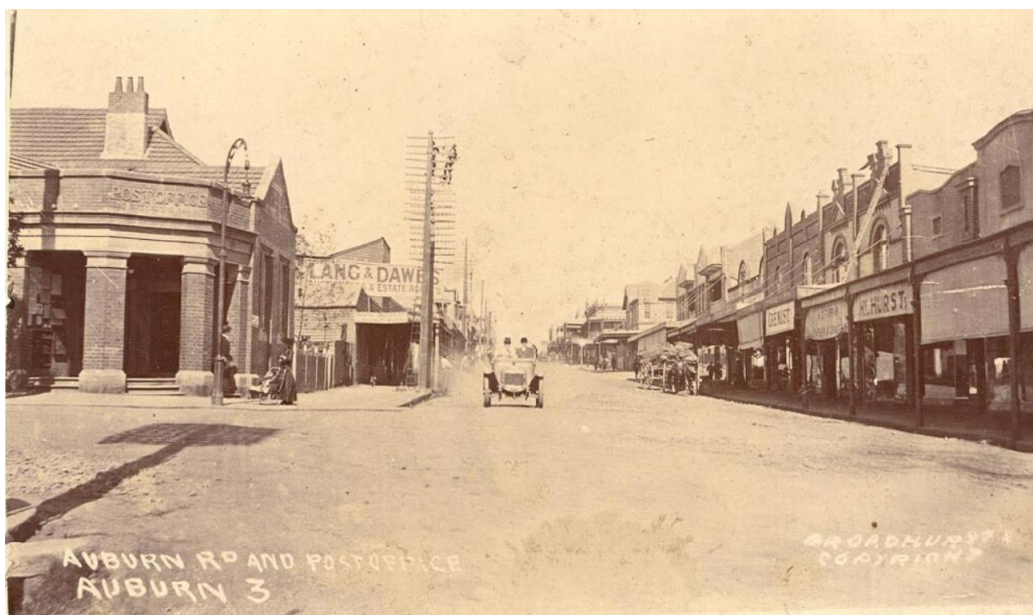
View along Auburn Road c.1912-1920, showing Auburn Post Office (left) as it originally stood
(Source: SLNSW Call No. PXA 635/19-24)

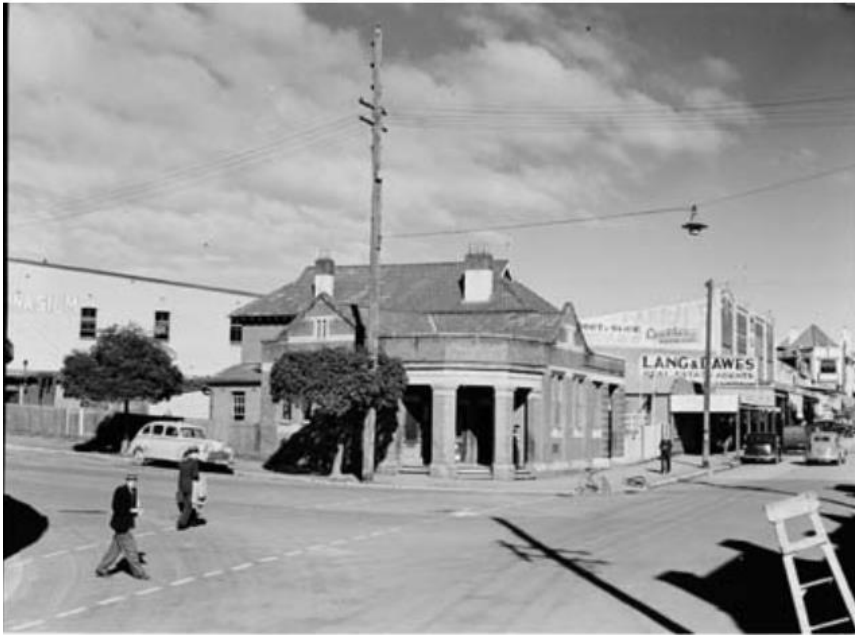
Auburn Post Office 1947 (Source: National Archives of Australia, Item No. 1649731)
