DETAILED ENVIRONMENTAL SITE INVESTIGATION

**Gladstone Street, 4 Terminal Place & 4A Terminal Place
Merrylands NSW 2160**

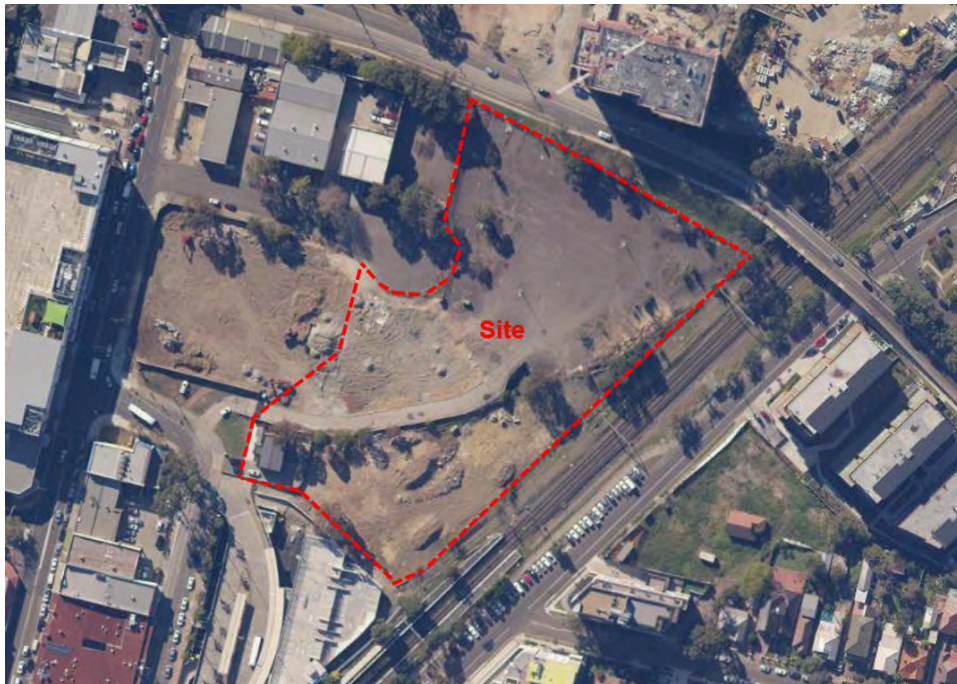
Figure 2.2 – Site Layout

The Site is outlined in red and surrounding properties shown on Figure 2.2 – Site Layout.

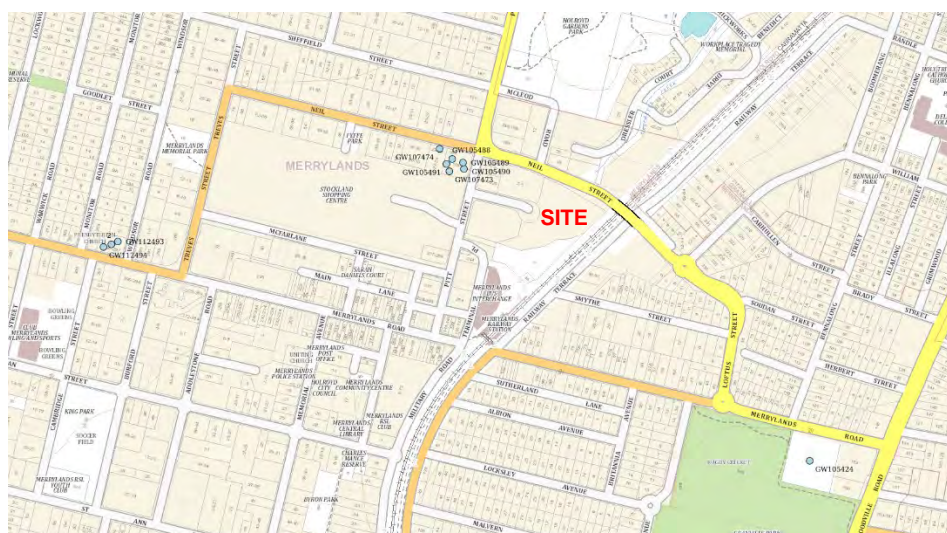
Figure 3.1 – Groundwater Bore Locations

An extract from the Minview database showing registered groundwater bores is presented in Figure 3.1 – Groundwater Bores with the approximate location of the Site shown in red and groundwater bores shown in blue.

The groundwater bores to the north-west and west are considered to be for monitoring purposes associated with underground petroleum storage systems. It is not considered likely that groundwater is extracted for irrigation purposes in either of these areas.

The groundwater bore to the south-east is located on park land, next to a football field and is listed as functioning for irrigation purposes.

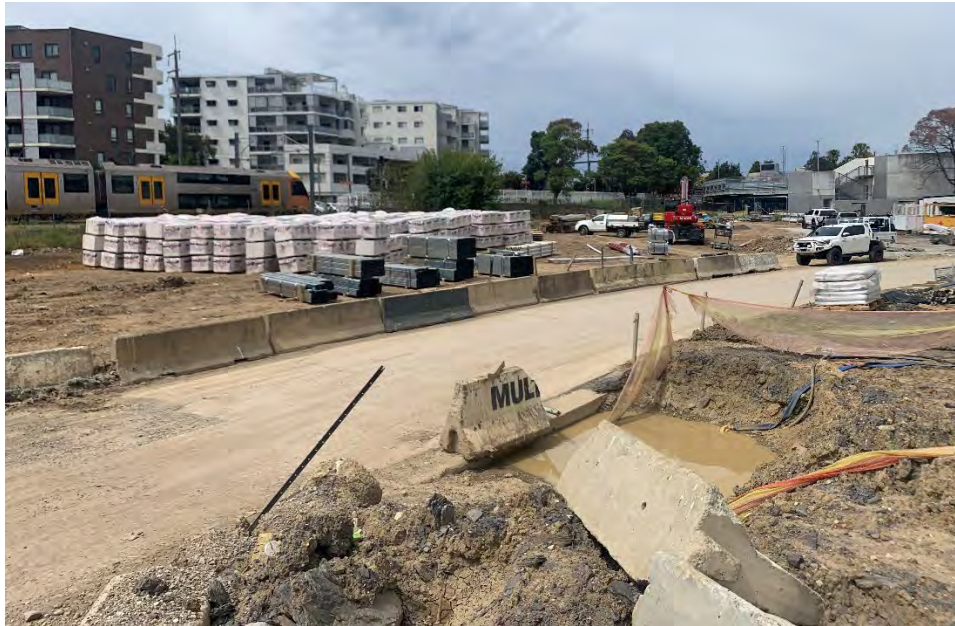
The general Site conditions at the time of the inspection are shown on Figure 7.1 – Site Appearance (west) and Figure 7.2 – Site Appearance (east).

At the time of this investigation, the Site was vacant land although some building materials were being stored along the southern boundary. The surface soil conditions encountered across the Site generally consisted of disturbed natural clay with sand and traces of gravel.
