PRELIMINARY CONTAMINATION ASSESSMENT

**LOTS 2 & 3 IN DP554208, LOT A IN DP335578, LOT 472 IN DP1204429 AND
LOTS 1 & 2 AND LOTS 8-12 IN DP24728
222-266, 268-280, 282, 284 DUNMORE STREET AND
83, 85, 87, 89, 91, 93, 105 PENDLE WAY, PENDLE HILL**

REPORT NO 14467/1-AAR1

23 July 2019

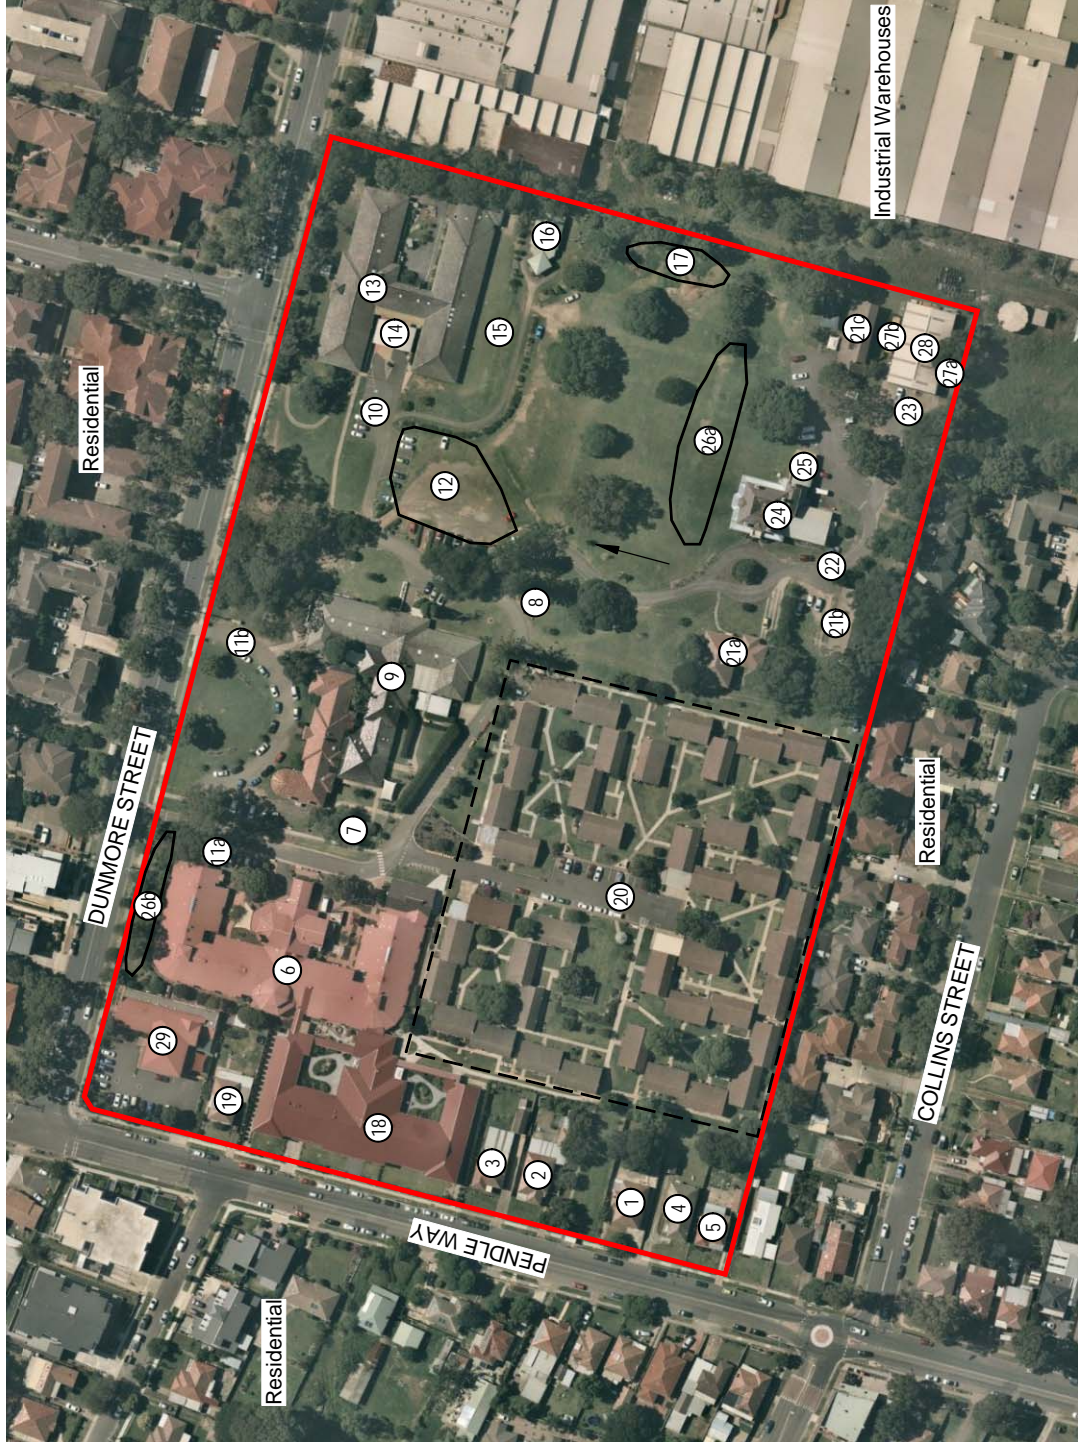
**DRAWING NO 14467/1-AA1: SITE FEATURES
and
SURVEY PLAN NO 15214 - T3**

As shown on Drawing No 14467/1-AA1 and the attached Survey Plan No 15214-T3, the site is rectangular, measuring about 330 metres (m) along the Dunmore Street and 220m along Pendle Way, covering an area of 7.31 hectares (ha).
