# SCHEDULE OF CONSERVATION WORKS

"The Wattles"

245 Great Western Highway, South Wentworthville

October 2021

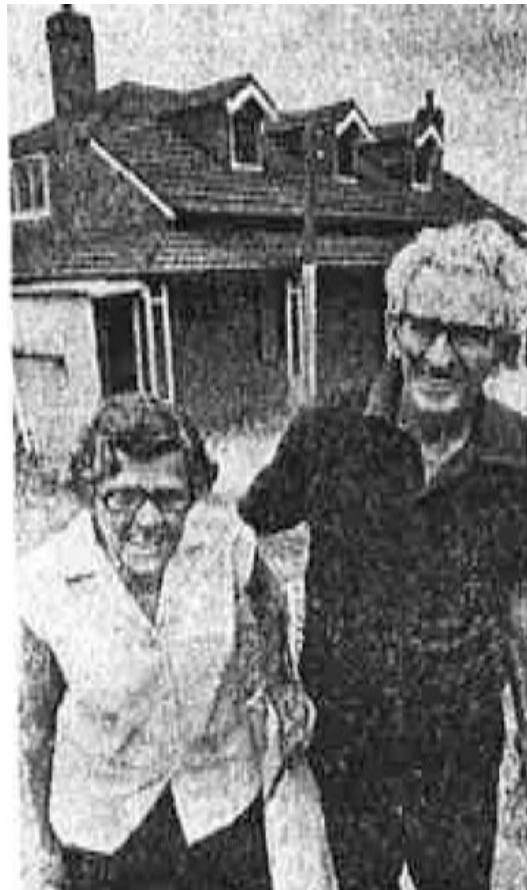
Figure 2.4 | Photograph published in the *Daily Telegraph*, 3 December 1980, shows tiles on the main roof and verandah and an attic level window and structure attached to the verandah on the eastern side of the building.

Replace tiles on main roof, verandah and dormers with galvanised corrugated steel.

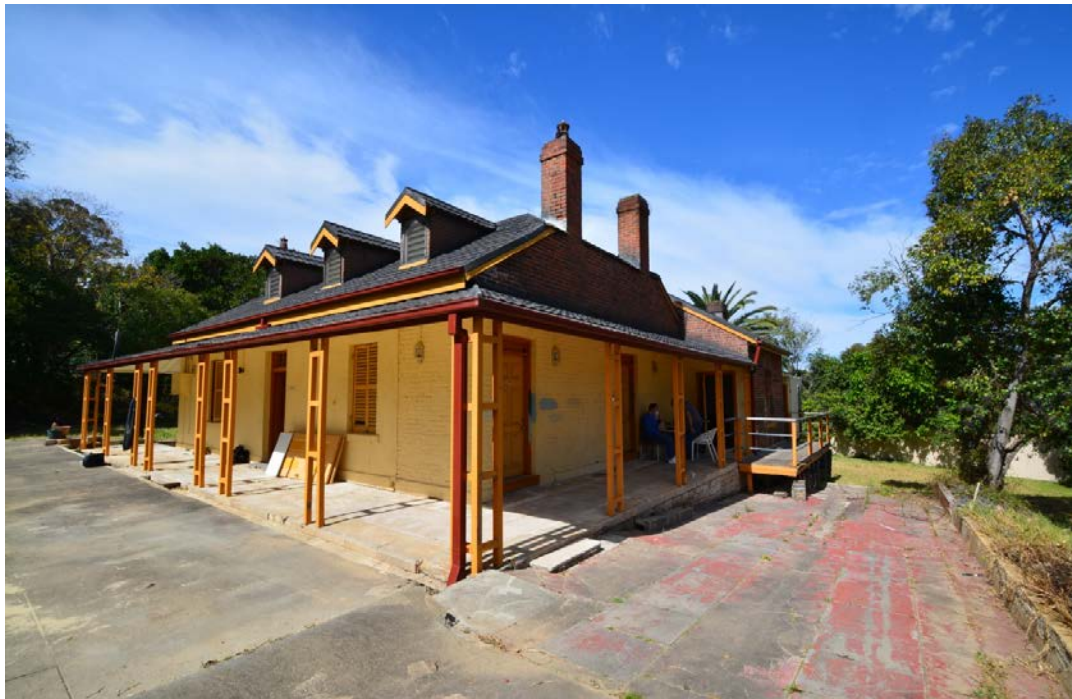
The walls of "The Wattles" are constructed of brick, which is in fair condition. A layer of cement render has been applied to a large section of the northern (front) elevation. The eastern, northern and western elevations of the main house have been painted, as have the south walls of the two rear wings.

Figure 2.5 I "The Wattles" viewed from the north-west.

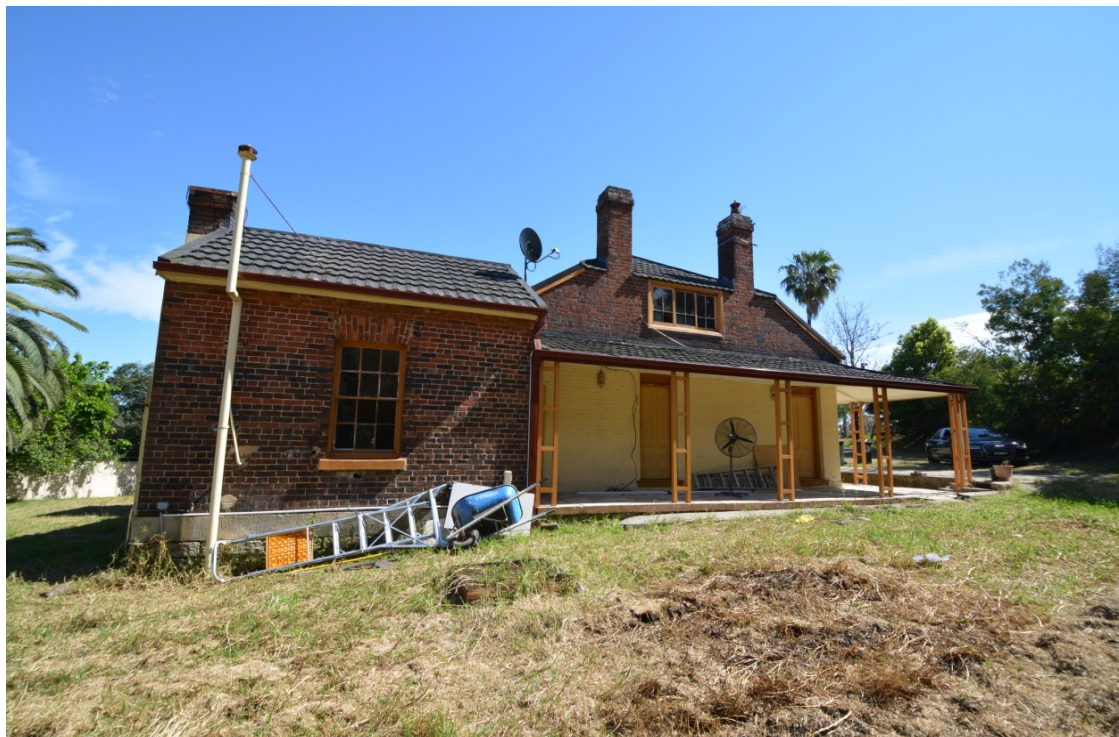
Figure 2.6 | "The Wattles" viewed from the east.

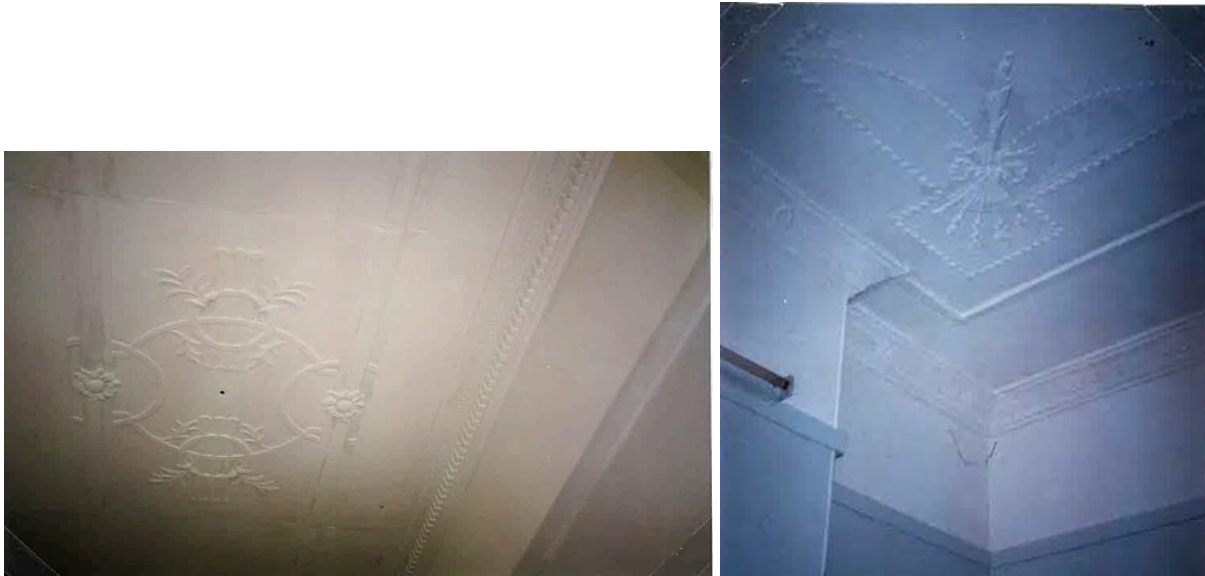
Earlier ceilings may remain in place above the existing ceilings. 1997 photographs show these to have been decorative fibrous plaster linings installed during the interwar period.

Figure 2.9 | Photographs of ceilings included in the 1997 Broomham history.

**Note** that although ceilings installed during the 1920s were probably removed for the installation of new linings, they may possibly remain above existing ceiling linings. Leave existing ceiling linings in place to conserve the earlier linings, if still in place.
