# **Heritage Inventory Sheet**

Hom Name	The Trangete Vieterian Craun				
Item Name	The Trongate Victorian Group				
Recommended Name	The Trongate Victorian Terrace Group				
Site Image					
Address	90, 92, 94, 96, 98 The Trongate, NSW 2142				
Lot/Section/DP	1 to 3		-	219451	
	A and B		-	106943	
Current LEP ID	I105 (Cumberland LEP)				
Former LEP ID	I193 (Parramatta LEP)				
Heritage Conservation Area	Not included				
Date Updated	March 2020				
Significance Level	LOCAL				
Site Type	Level 1	Built			
	Level 2	Residen	ntial buildings (private)		
Ownership	90 - Mr. Kwan So Ha Wong (19 Neich Parade, BURWOOD NSW 2134); 92 - Mr. Kon Daskalos (97 Bennalong Street, MERRYLANDS NSW 2160); 94 - Mr. Kevin Luke Hegarty (94 The Trongate, GRANVILLE NSW 2142); 96 - Mr. Antonio Jose Dos Santos Ramires (96 The Trongate, GRANVILLE NSW 2142); 98 - Mr. Steven Kenneth Orlowski, Ms Kathleen Orlowski (98 The Trongate, GRANVILLE NSW 2142); 100-102 - Mrs. Christina Kathleen Jenson, Mr Robert John Jenson (102 The Trongate, GRANVILLE NSW 2142)

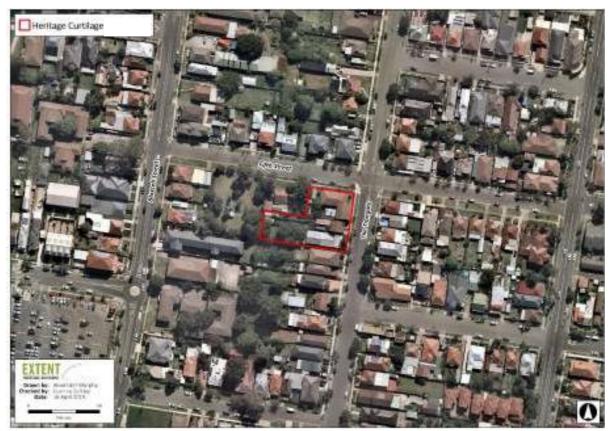
## Curtilage Map

Revised Curtilage recommended - refer below.

It is recommended that the heritage curtilage for I193 (Parramatta LEP) is revised as shown below due to the different styles of the dwellings. It is most appropriate to separate the site into two heritage listings including the single storey semi-detached cottage (No.100 and No.102), and the group of Victorian terraces (No.90, No.92, and No.94 No.98 and No.96). This listing sheet has been updated to reflect this recommendation. Please see I107 (Cumberland LEP) for the 'Victorian Semi-Detached cottage'. The noted Lot/DP for this listing sheet is accurate and reflects this revised curtilage.
