# Heritage Inventory Sheet

Item Name	St Peter C	Chanel S	chool Hall, Church and R	lectory		
Recommended Name	St Peter C	St Peter Chanel School Hall, Church and Presbytery				
Site Image						
Address	60–66 Kingsland Road, Berala NSW 2141					
Lot/Section/DP	A and B - 323658					
	1 and 2	1 and 2 - 589907				
Current LEP ID	I23 (Cum	I23 (Cumberland LEP)				
Former LEP ID	I25 (Auburn LEP)					
Heritage Conservation Area	Not included					
Date Updated	March 2020					
Significance Level	LOCAL					
Site Type	Level 1 Built					
	Level 2 Religion					
Ownership	Departme	Department of Education & Training

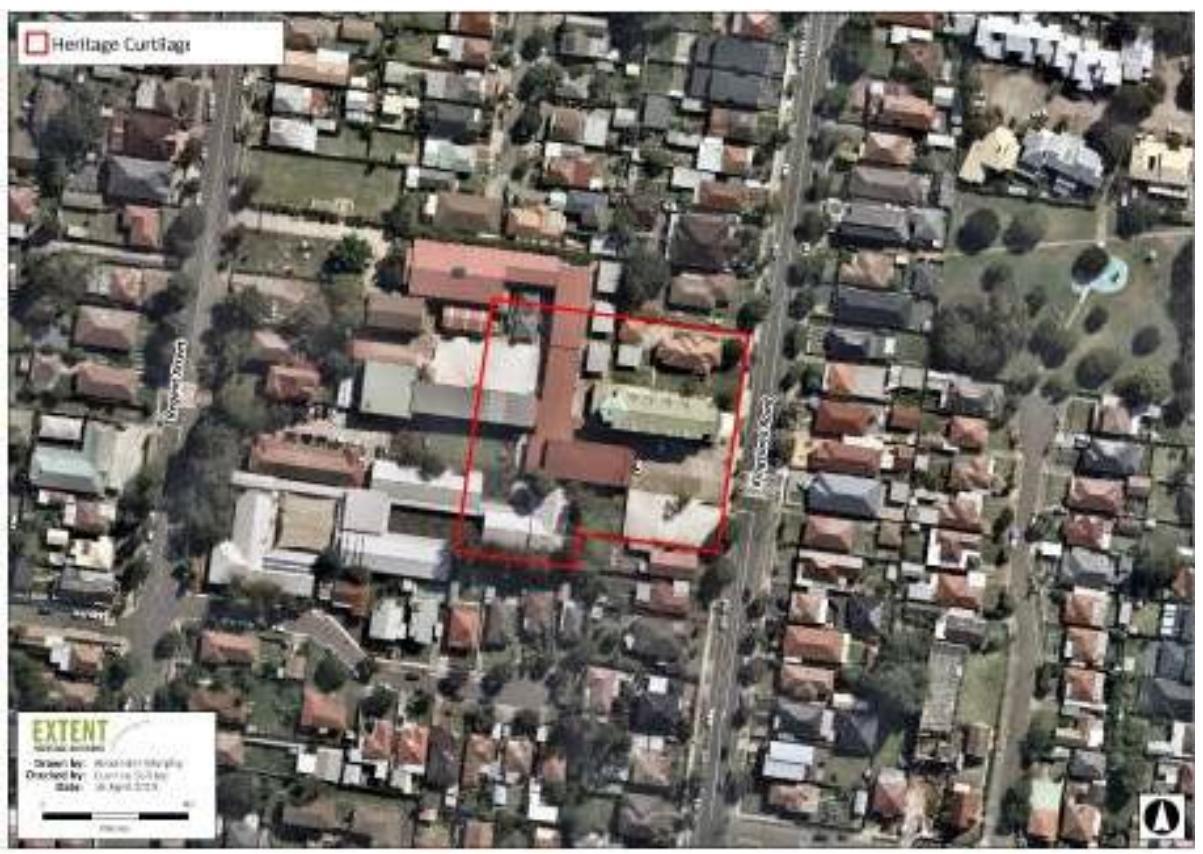
# Curtilage Map

Revised curtilage recommended- see below.

- As the listing concerns the church, hall and presbytery only, the heritage curtilage shown below should be considered as a revised curtilage for the new Cumberland Council LEP.
- Should the revised curtilage be adopted, this listing sheet does not reflect the current Lot/DP which will need to be altered.

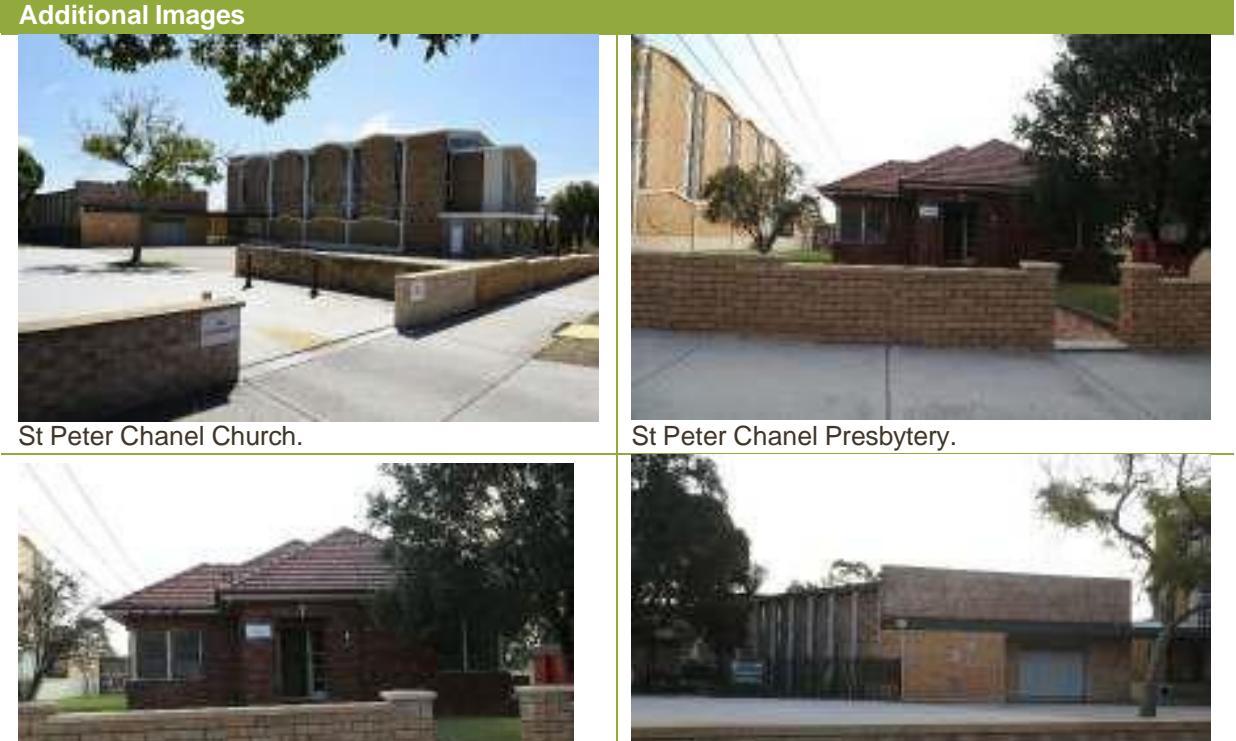
St Peter Chanel Presbytery.

Berala Jubilee Hall.
