Heritage Inventory Sheet

Item Name	Uniting Church Auburn Parish and adjacent Victory Hall		
Recommended Name	Uniting Church Auburn Parish and Victory Hall		
Site Image	 		
Address	Northeast corner of Helena Street and Harrow Road, Auburn NSW 2144		
Lot/Section/DP	24	11	68372
	25-27	11	982836
Current LEP ID	I11 (Cumberland LEP)		
Former LEP ID	I21 (Auburn LEP)		
Heritage Conservation Area	Not included		
Date Updated	March 2020		
Significance Level	LOCAL		
Site Type	Level 1	Built	
	Level 2	Religion	
Ownership	Uniting Church NSW Trust Association

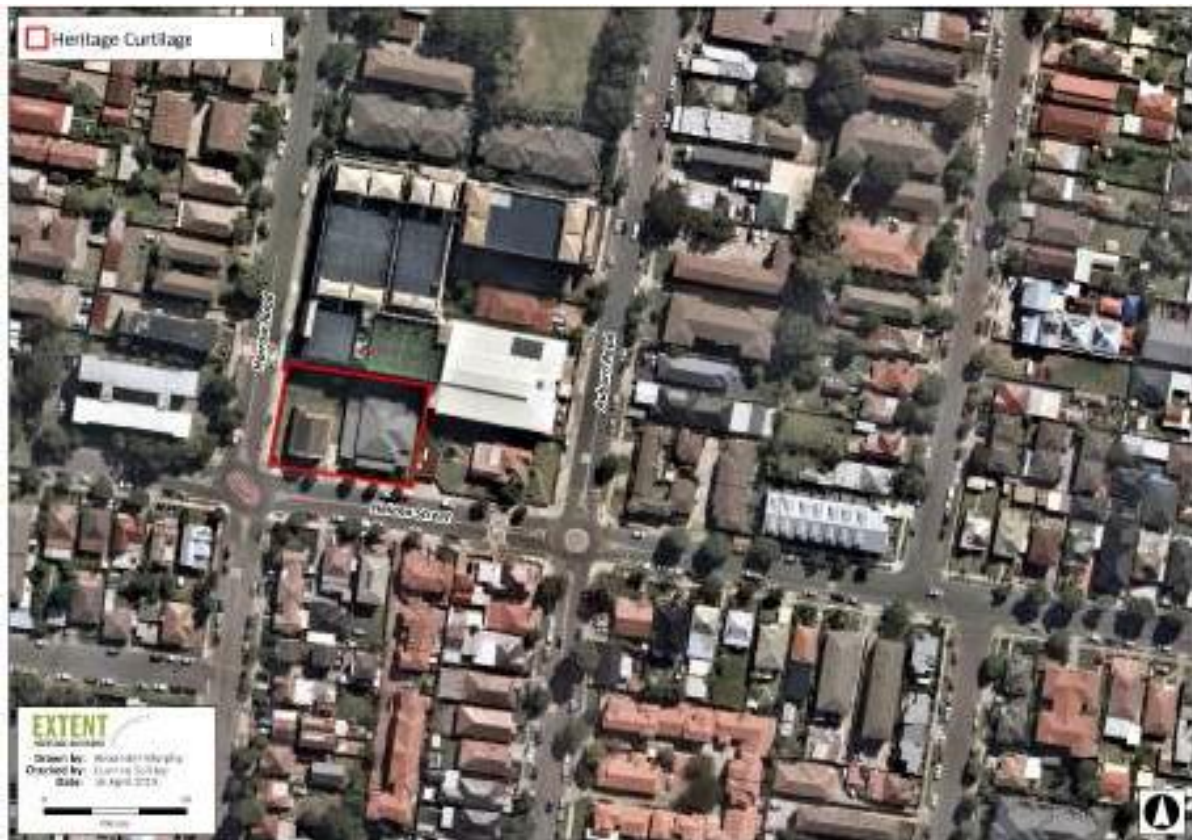
Curtilage Map

Revised curtilage – refer below.

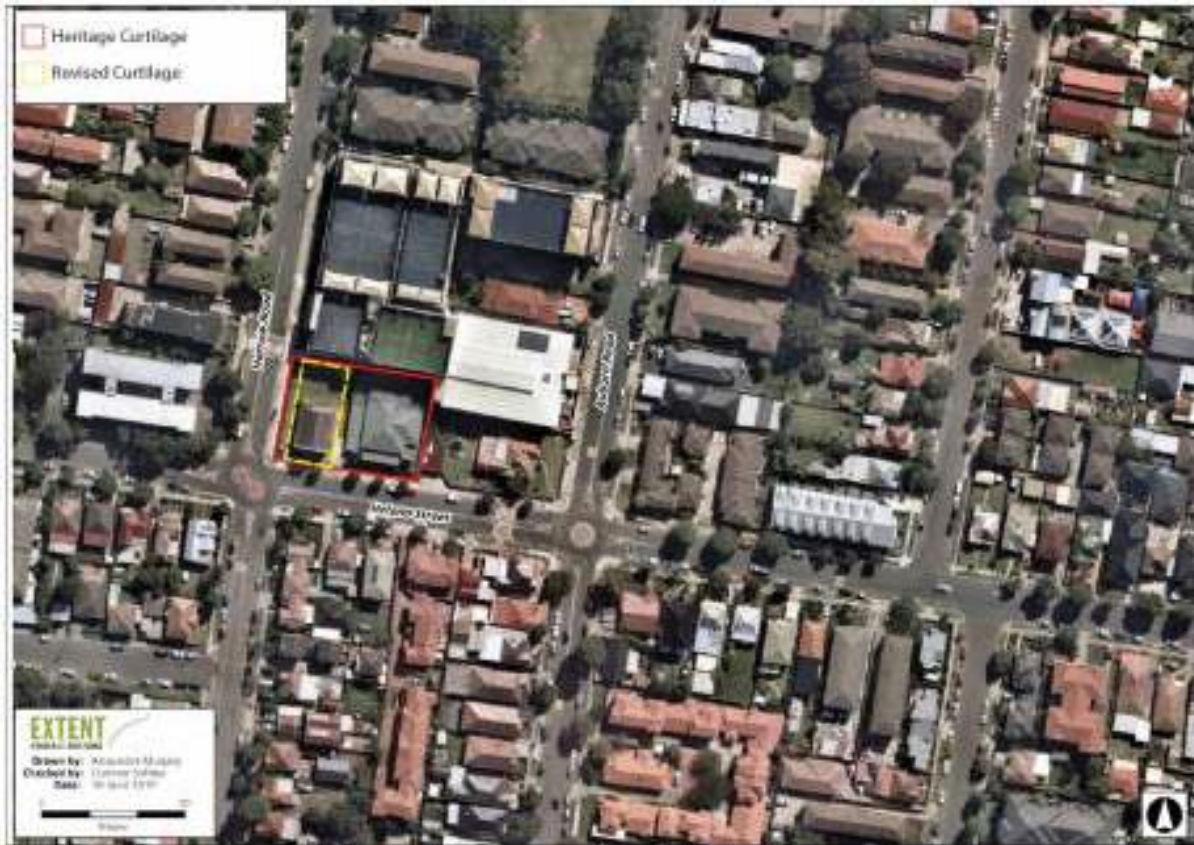
- Due to construction the contemporary Victory Hall it is recommended the curtilage be revised to embody the Church and the garden landscape alone. The heritage curtilage shown below should be considered as a revised curtilage for the Cumberland LEP.
- Should the revised curtilage be adopted, this listing sheet does not reflect the current Lot/DP which will need to be altered.

5. The heritage curtilage for this item should be revised/reduced.	X	10. Maintain the historic aesthetic/character of the item and area (e.g. paint scheme, materiality, style, landscape elements).	X

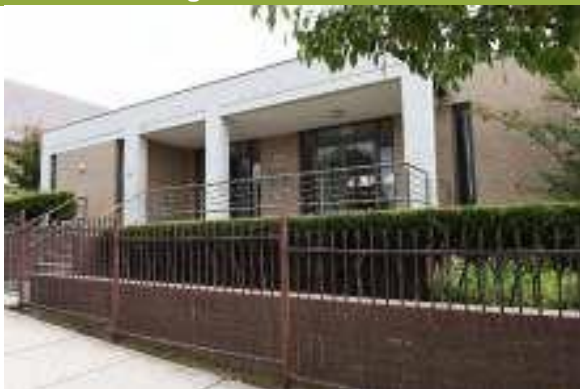
The Victory Hall, built in the 1920s of weatherboard, was destroyed by fire in 2005. It has since been replaced by a new, modern church hall building to the immediate east of the church, fronting Helena Street.

New Victory Hall.

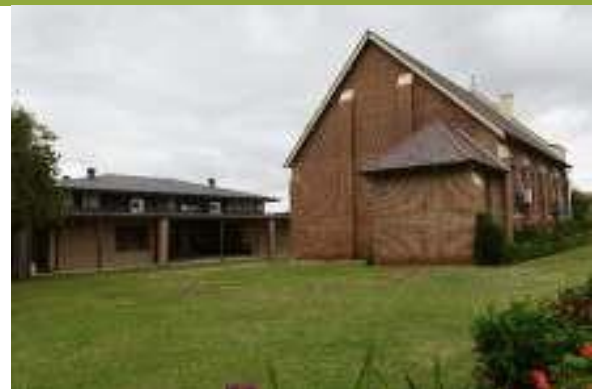
Overall, the Church is in a good condition.

Uniting Church.

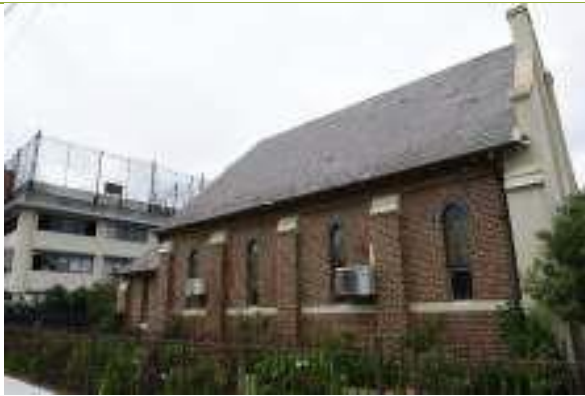
The main façade of the church is a large, gable-ended, oversize façade element with a prominent parapet, with engaged piers. In the gable above the centralised door is a window opening with a moulded pointed arch and two smaller, narrow stained-glass windows with pointed arches. The side and rear facades are unpainted brick, with narrow windows with pointed arches located between the engaged piers of the main side walls of the Church. The cement sills span between the buttresses.

Side elevation of Uniting Church.

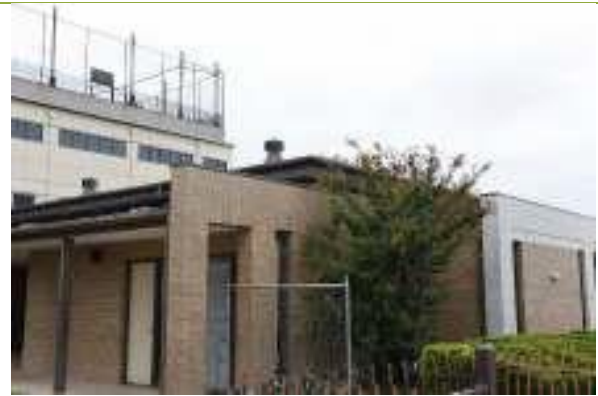
Rear and side elevations of New Victory Hall.
