Heritage Inventory Sheet

Item Name	Berala Railway Station		
Recommended Name	Berala Railway Station Group		
Site Image

Address	Campbell Street, Berala NSW 2141		
Lot/Section/DP	2	-	803675
Current LEP ID	A5 (Cumberland LEP)		
Former LEP ID	A53 (Auburn LEP)		
Heritage Conservation Area	Not included		
Date Updated	March 2020		
Significance Level	LOCAL		
Site Type	Level 1	Built	
	Level 2	Transport - Rail	
Ownership	Rail Corporation New South Wales

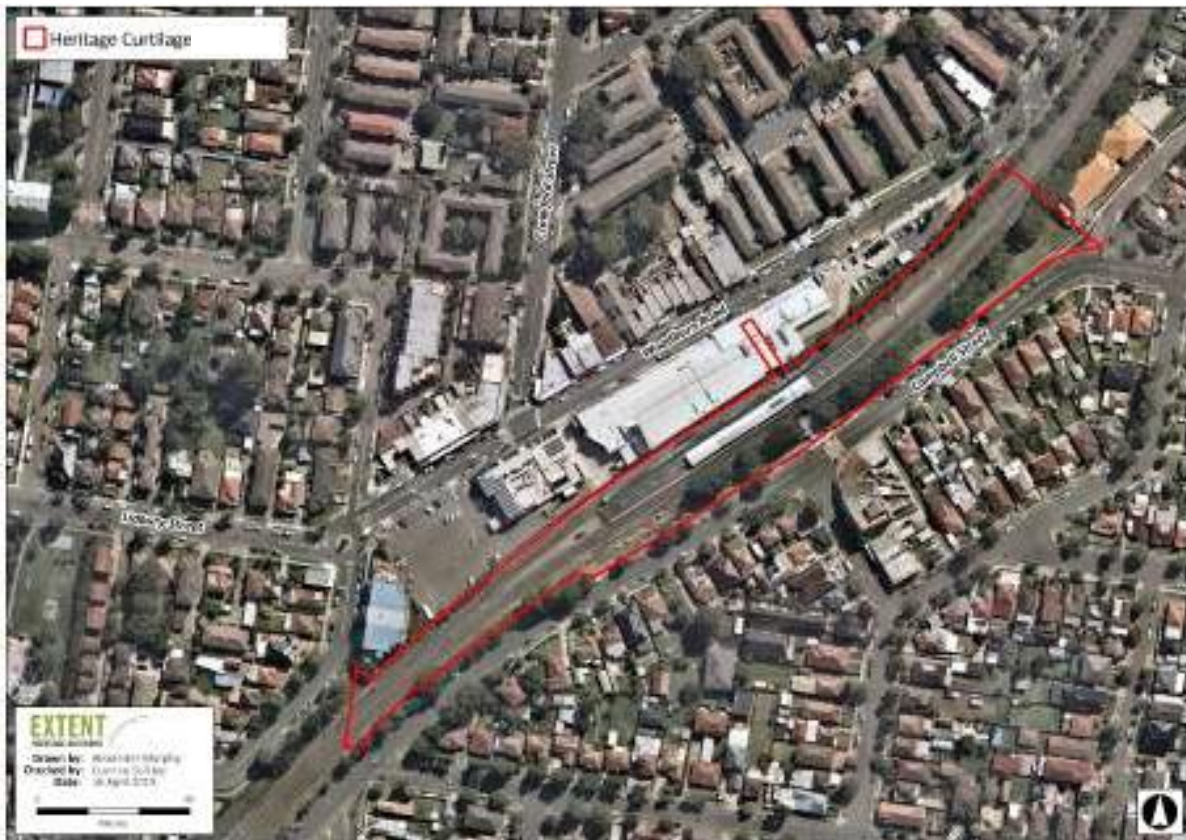
Curtilage Map

Revised curtilage recommended- see below.

- The heritage curtilage of Berala Railway Station should be revised to match the RailCorp Section 170 Heritage and Conservation Register curtilage for the station (below); see item #4800211. This curtilage would retain the subway.
- Should the revised curtilage be adopted, this listing sheet does not reflect the current Lot/DP which will need to be altered.

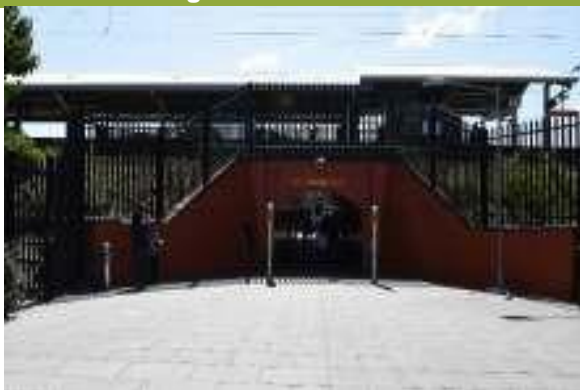
The subway which runs under the elevated tracks and platform connects the station to Woodburn Road in the north and Campbell Street in the south. The subway has brick walls, a brick barrel vault and ceramic tiled stairs leading up to the platform.

Entrance tunnel to Berala Railway Station.

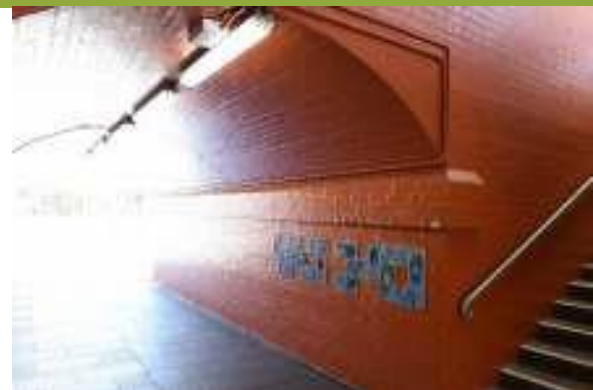
The subway is in moderate condition. There is organic growth and dampness to some of the walls surfaces.

Tunnel under Berala Railway Station.

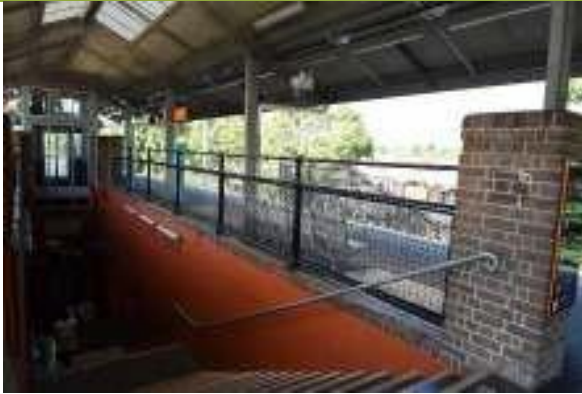
View to Platform.

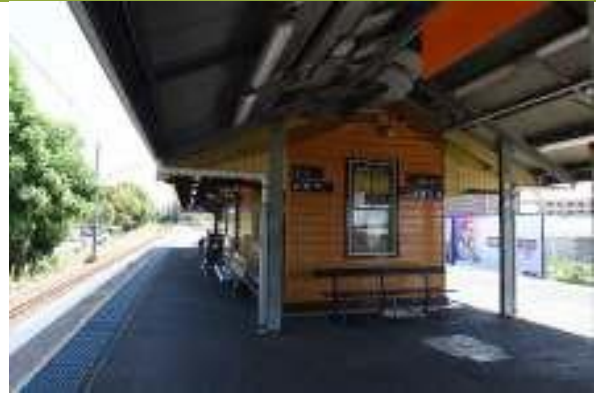
Platform 1 (Up) and Platform 2 (Down) have in-situ concrete faces and asphalt surfaces and together they form an island platform arrangement. The platforms are raised as compared to the surrounding area and road level.

The platforms are in good condition.

View to Platform 1 and 2.
