## Heritage Inventory Sheet

<b>Item Name</b>	New York Street Group		
<b>Recommended Name</b>	New York Street Group		
<b>Site Image</b>	 		
<b>Address</b>	12-14, 13 and 18-24 New York Street, Granville NSW 2142		
<b>Lot/Section/DP</b>	10	-	1037057
	1-2	-	137124
	1	-	152709
	A	-	318121
	102	-	827912
	11	-	84371
	14	-	999601
<b>Current LEP ID</b>	I75		
<b>Former LEP ID</b>	I154 (Parramatta LEP)		
<b>Heritage Conservation Area</b>	Not included		
<b>Date Updated</b>	March 2020

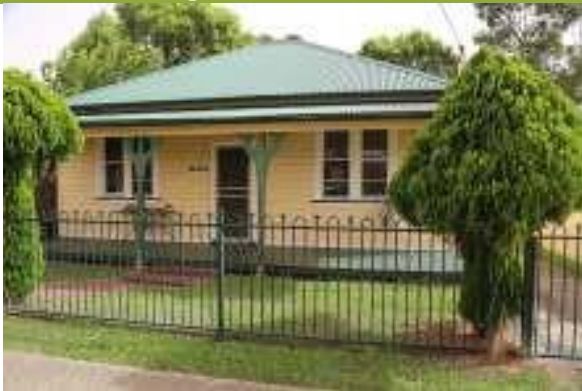
No. 13 is a hipped roof cottage with Colorbond sheeting which extends over the awning. The awning is supported on decorative timber posts set into a timber porch. The centrally placed door is covered by a modern security screen. The door is flanked by timber double hung windows in sets of two. The dwelling has a building name panel spelling out "Stirling". The property is bound by a green, low style pool fence and the front setback is largely grassed with some young plantings along the fence line. A concrete driveway has been provided along the eastern edge of the property.

13 New York Street, front façade.

- Aluminium looptop and arrowhead boundary fence\*
- Skillion roof rear extension,
- Colorbond roof and verandah sheeting,
- Security screen door
- Paved brick footpath.

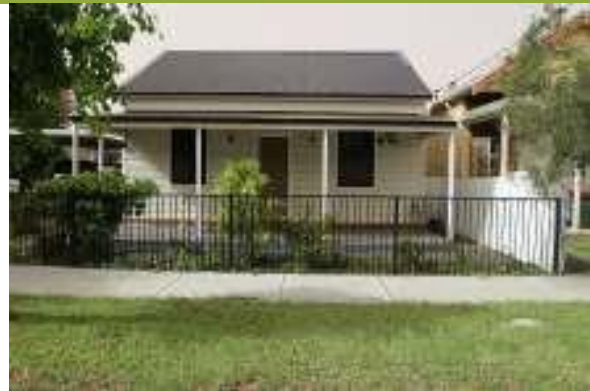
No. 18 has a single gable roof which has been replaced with Colorbond. The awning has also been replaced in a matching material, along with the timber posts which are now steel. The central door is covered by a modern security screen as are two timber double-hung sash windows flanked on either side of the door. Along the eastern elevation, the building is clad with fibro sheeting. The property is bound by a modern palisade fence and the front setback is largely paved, with some young plantings along the fence line. The building has a single-storey skillion extension to the rear.

18 New York Street, front façade.

- Rear single-storey skillion extension,
- Replacement of bullnose awning with a skillion style awning clad in Colorbond\*,
- Replaced roof sheeting,
- Contemporary aluminium ladder fence\*,

- Security screens to windows and doors,
- Concrete driveway,
- Rendered side elevation – weatherboard cladding removed.
- Skillion carport

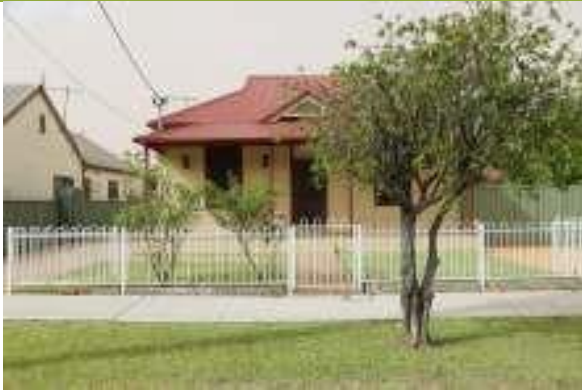
No. 14 has a gabled hipped roof with a central gable with decorative timber detailing. The central door is covered by a modern security screen as are two timber double-hung sash windows flanked on either side of the door. The property is bound by a white, low pool-style fence and the front setback is largely grassed with some young plantings along the fence line. The building has a single-storey skillion extension to the rear.

14 New York Street, front façade.

- Rear single-storey skillion extension
- Aluminium security screens to windows and doors,
- Aluminium looptop fencing to property boundary\*,
- Replaced roof sheeting
- Solar panels to roof of rear extension
- Colorbond pressed metal side gate/fence.

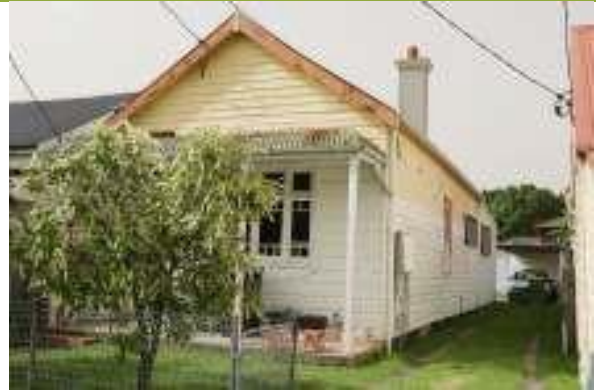
No. 20 has a single gable presenting forward towards the street with a decorative timber bargeboard, corrugated iron roofing and a rendered brick chimney with a cornice and single terracotta cowl. The bullnose awning is corrugated iron with timber posts onto a concrete porch slab. The Federation style

five-panelled door, offset from the centre of the building, has two small glazed panels above a large square glazed pane with two timber bolection mould panels below lock rail. To the right of the door are three timber windows with sets of six colour panes and a transom window at the top. The dwelling has been extended to the rear with a single-storey skillion structure in weatherboard.

Overall the condition of the group is good. Many of the dwellings present as recently renovated cottages with new roofs and paint schemes. The cottage at 20 New York Street shows signs of rusting along the bullnose of the verandah roof and some slightly deteriorated timber weatherboards in the gable end.

20 New York Street, front façade.

- Rear single-storey skillion extension in weatherboard,
- Modern carport at the rear,
- Security screen door,
- Roller awning along east elevation,
- Replaced roof sheeting,
- Concrete verandah floor\*
- Weldmesh fence along the property boundary\*
- New paint scheme.

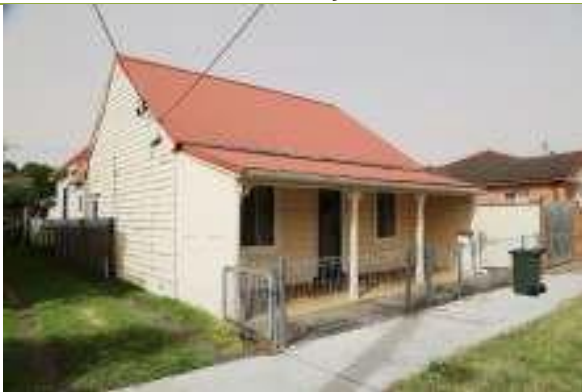
No. 22 is a single gable cottage with a corrugated iron roof and awning, set over a concrete porch with chamfered timber posts. The gable end has a decorative bargeboard in timber. Decorative lace brackets have been added to the awning. The porch is closed in on both ends with fibro sheeting. The central door is covered by a modern security screen as are two aluminum windows flanked on either side of the door. The dwelling is bounded by a cyclone fencing to the front, unpainted timber slat fencing along the eastern side and Colorbond fencing along the western side. The building has a single-storey skillion extension in weatherboard to the rear.

22 New York Street, front façade.

- Rear single-storey gabled extension in weatherboard with Colorbond roofing,
- Security screens to windows and door openings,
- Contemporary aluminium window frames,
- Fibro privacy screen infills,
- Weldmesh fencing\*

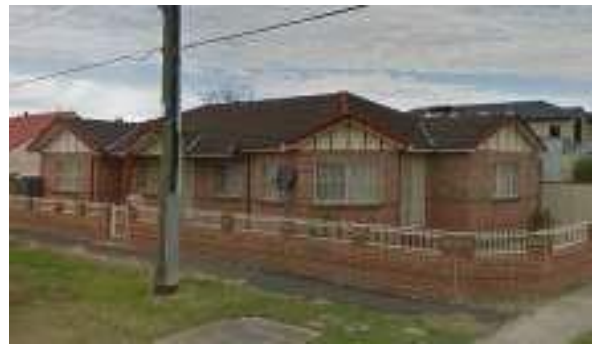
No. 24 is a late twentieth century face brick building, constructed with Federation style detailing. It is a single-storey dwelling with a tiled hipped roof with four gables. Windows are aluminum with security bars across each. The dwelling is bound by a face brick fence with decorative palisade inserts.

The original cottage at 24 New York Street, shown in the 1943 aerial image for the site, was demolished and replaced with the current dwelling. This likely occurred in the 1990s or 2000s, based on the style of the current dwelling.

24 New York Street, Granville, new build.

- Due to the demolition of and the subsequent modern development 24 New York Street, Granville, the heritage curtilage of this item should be revised to exclude the dwelling at 24 New York Street. It is recommended the revised curtilage shown below is updated as the accurate heritage curtilage of the item for the Cumberland LEP.
- Should the revised curtilage be adopted, this listing sheet does not reflect the current Lot/DP which will need to be altered.
