Heritage Inventory Sheet

Item Name	Federation Period Cottage		
Recommended Name	Federation Cottage		
Site Image	 		
Address	20A The Esplanade, Guildford NSW 2161		
Lot/Section/DP	445	-	1039110
	-	-	SP 73518
Current LEP ID	I167 (Cumberland LEP)		
Former LEP ID	I50 (Holroyd LEP), Federation Period Cottage		
Heritage Conservation Area	Not included		
Date Updated	September 2019		
Significance Level	LOCAL		
Site Type	Level 1	Built	
	Level 2	Residential buildings (private)

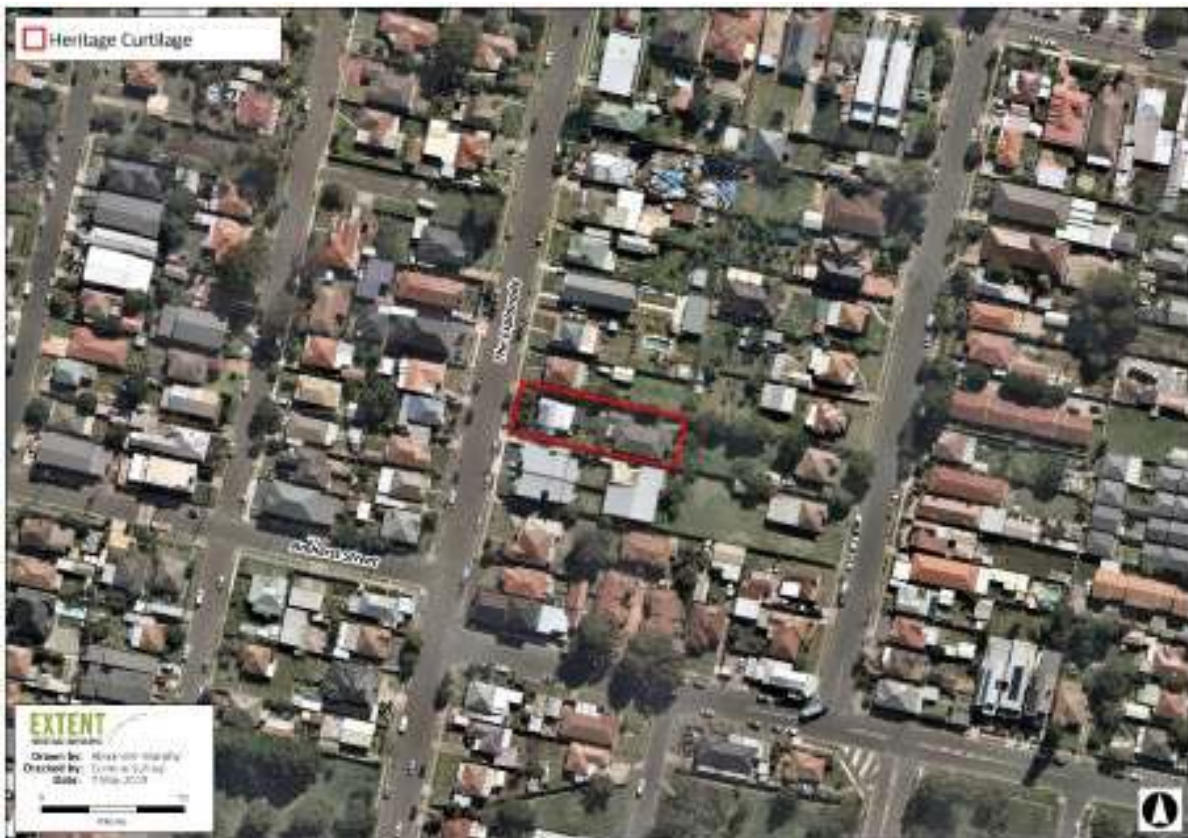
Curtilage Map

Revised curtilage recommended – refer below

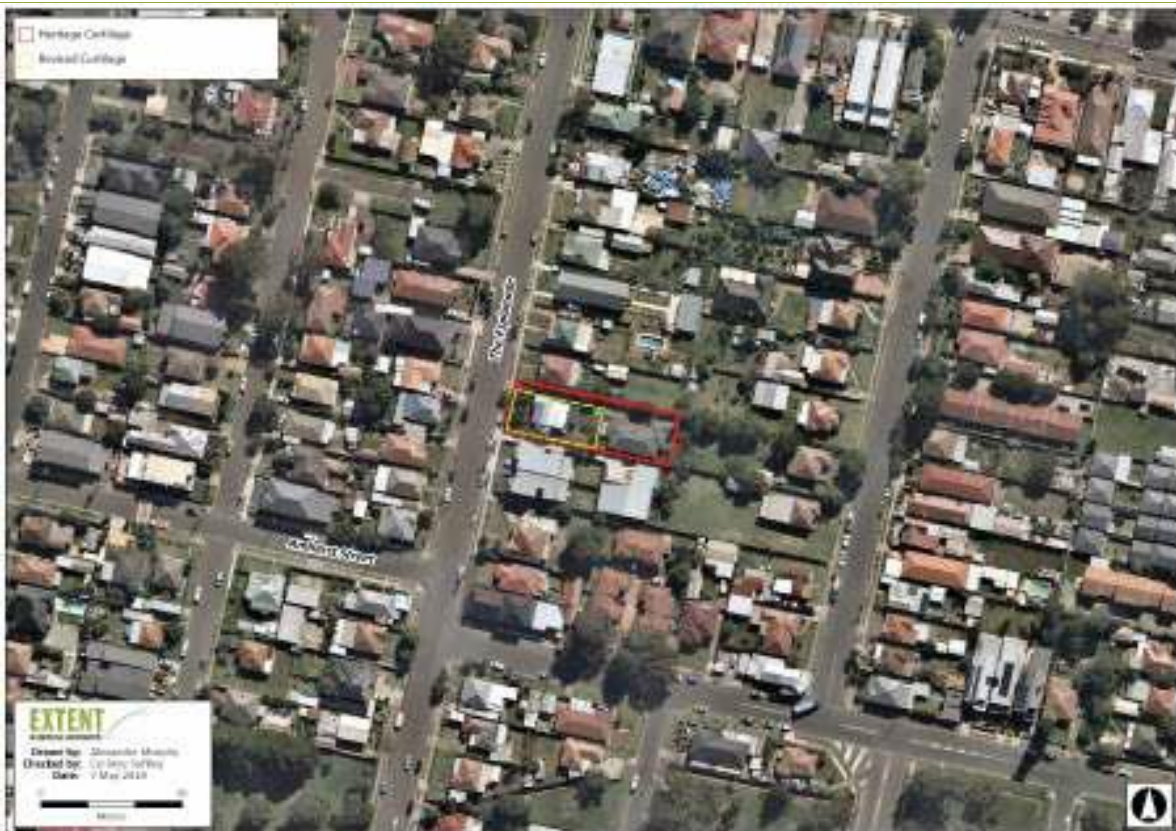
- As the eastern portion of the current site includes a modern dwelling of no heritage value, the heritage curtilage shown below should be considered as a revised curtilage for the new Cumberland LEP. Note: the curtilage follows the boundary of 20A vs the strata lot.
- Should a revised curtilage be adopted, this listing sheet will no longer reflect the current Lot/DP and will need to be altered.

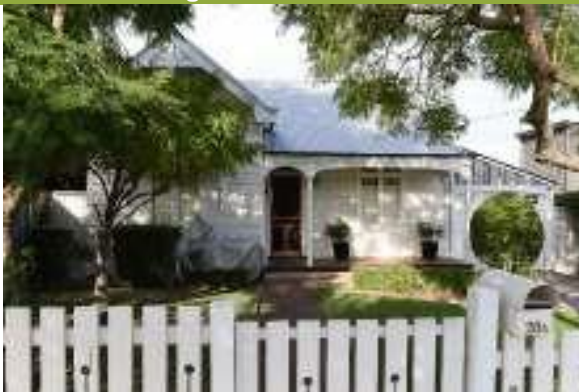
The subject building is a small L-shaped weatherboard cottage which features intersecting gable roofs clad in corrugated iron and a verandah to the south of a projecting gable roofed wing. The gable ends have projecting decorative barge boards and finials, and the front gable also features timber shingle cladding. The main roof extends over the front verandah and is supported on simple timber posts with capitals supporting arched frieze. The posts appear to be original. The verandah also features modern flooring. The front facade of the cottage has a panelled door with a toplight. The door is covered by a stained timber screen door. The façade also features two pairs of casement windows with decorative framing and sections of coloured glass. The window in the projecting wing also features a simple timber bracketed hood. Two different weatherboard profiles are visible on the side facades. The rear of the building has a skillion roofed extension.

Front façade.

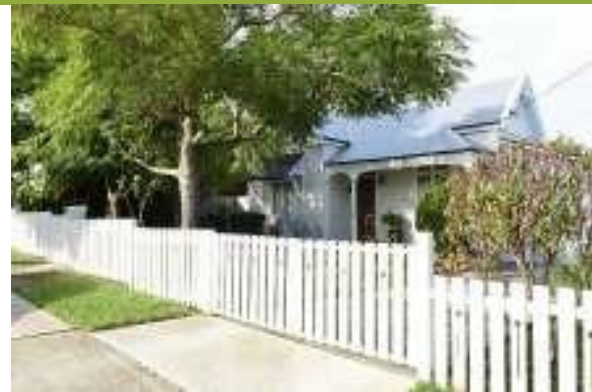
The front boundary has a timber picket fence and a driveway have been provided along the southern boundary. A number of mature trees are located on the south side of the house, in the open backyard and to the front. While significant in size, these appear to be contemporary plantings which were not on the site in 1992 during the previous assessment.

Fence.
