# Heritage Inventory Sheet

Item Name	Fenton House			
Recommended Name	Fenton House- Federation Commercial Building			
Site Image				
Address	35–47 Jos	35–47 Joseph Street, Lidcombe NSW 2141		
Lot/Section/DP	35 - 1018049			1018049
Current LEP ID	I185 (Cumberland LEP)			
Former LEP ID	I30 (Auburn LEP)			
Heritage Conservation Area	Not included			
Date Updated	March 2020			
Significance Level	LOCAL			
Site Type	Level 1 Built			
	Level 2 Commercial			
Ownership	Invocare Australia Pty Limited

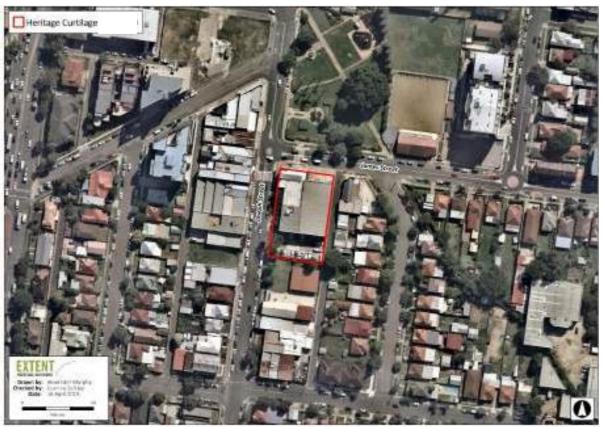
## Curtilage Map

Revised curtilage recommended - refer below.

- Should the opportunity arise, the air-conditioning units to the façade should be removed and the windows / walls made good. Further, the aluminium windows should be replaced with timber.
- As the listing should concern the original shop only, not the face brick extension and associated warehouse, the heritage curtilage shown below should be considered as a revised curtilage for the new Cumberland LEP.
- Should a revised curtilage be adopted, this listing sheet will no longer reflect the correct Lot/DP and will need to be altered.
