Heritage Inventory Sheet

Item Name	Inter-War Bungalow		
Recommended Name	Inter-war Bungalow		
Site Image	 		
Address	32 Garfield Street, Wentworthville, NSW 2145		
Lot/Section/DP	1-2	-	1201355
Current LEP ID	I271 (Cumberland LEP)		
Former LEP ID	I128 (Holroyd LEP)		
Heritage Conservation Area	Not included		
Date Updated	February 2020		
Significance Level	LOCAL		
Site Type	Level 1	Built	
	Level 2	Residential Building (Private)

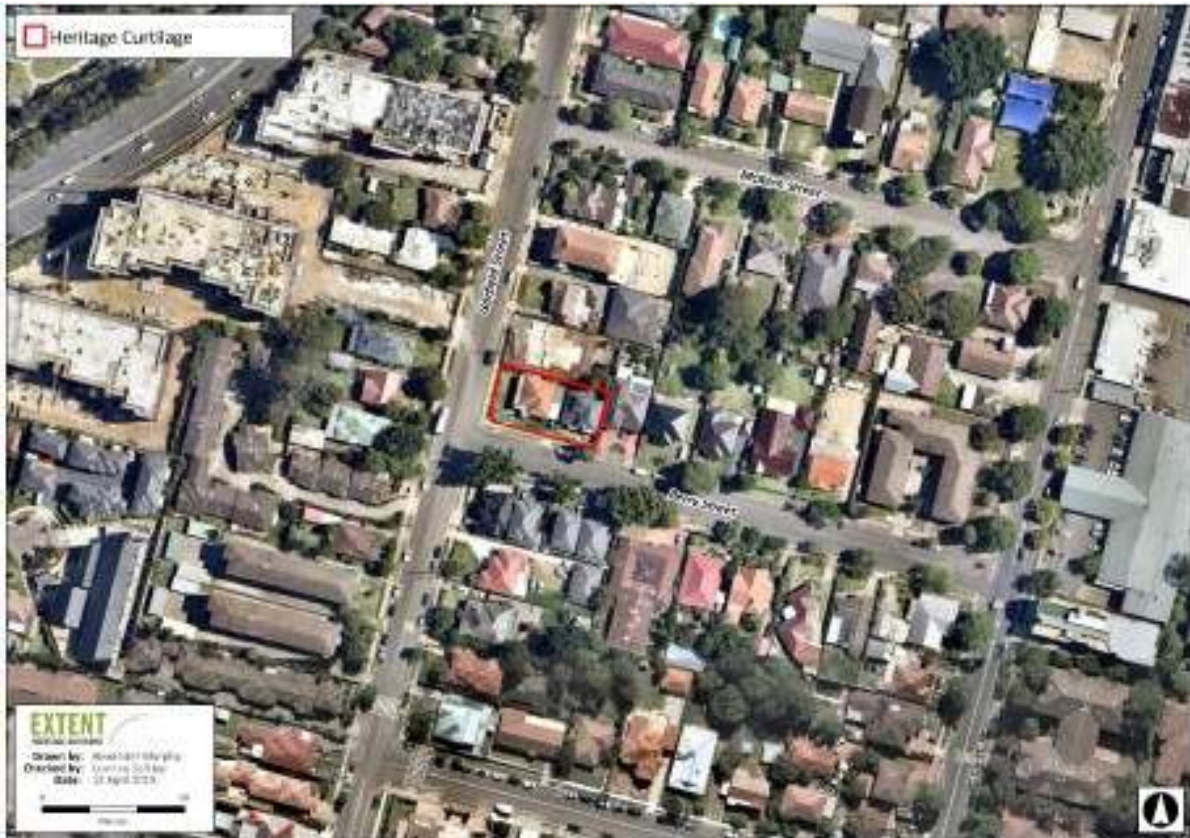
Curtilage Map

Revised curtilage recommended – refer below

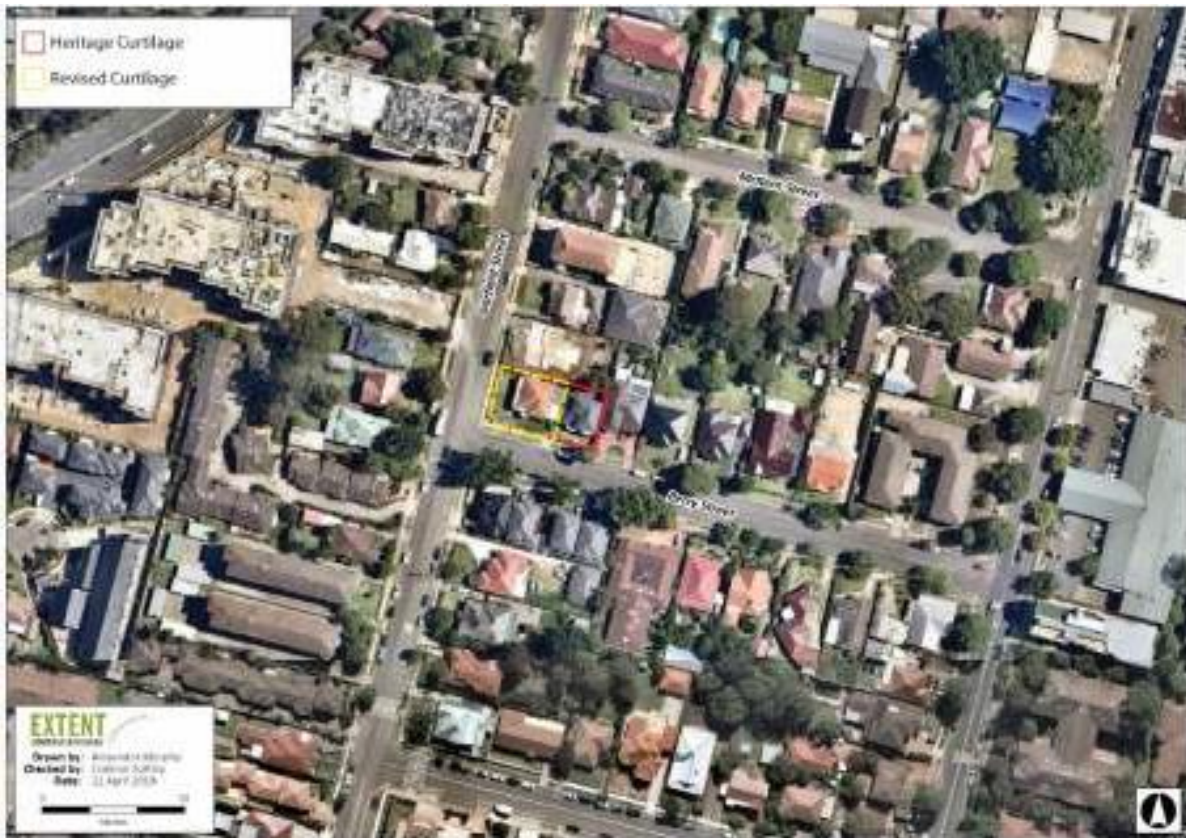
- As the eastern portion of the current site includes a modern two-storey dwelling of no heritage value and the two properties are subdivided, the heritage curtilage shown below should be considered as a revised curtilage for the Cumberland LEP. Should the revised curtilage be adopted, this listing sheet does not reflect the current Lot/DP which will need to be altered.

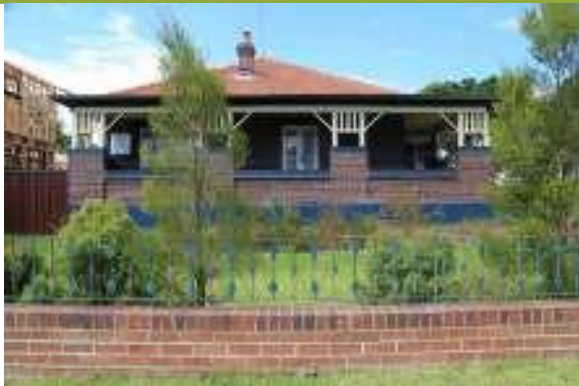
The property commands a prominent corner lot and is bound by a brick and decorative wrought iron fence. The building features a modest setback and is fronted by a mature garden with some contemporary landscaping. The back of the property is lined with a corrugated steel fence. While there is no specific landscape elements of value, the overall layout is contributory to the aesthetic significance of the place and should be managed accordingly.

View of dwelling from Garfield Street, including garden setting and fence.

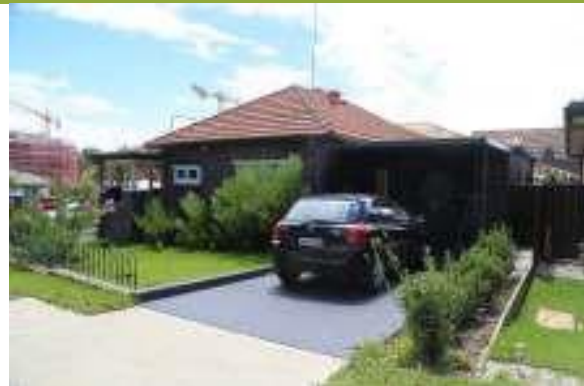
View of dwelling from Perry Street, including modern driveway and garden setting.

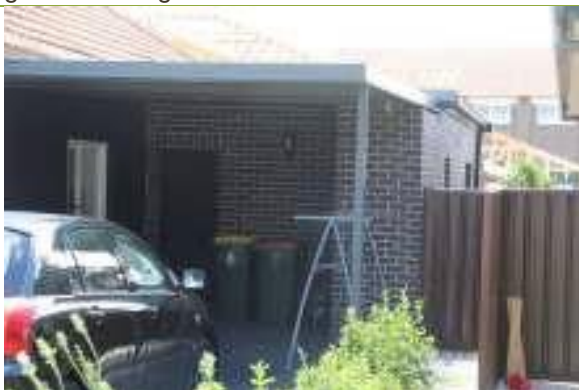
Although slightly modified, the building presents as a highly intact interwar bungalow. The rear additions are sympathetic to the buildings form, scale and materiality and do not adversely impact on the heritage significance of the item.

Detail of brick extension to dwelling.
