## Heritage Inventory Sheet

<b>Recommended Name</b>	Federation Bungalow		
<b>Site Image</b>

<b>Address</b>	291 Merrylands Road, Merrylands, NSW 2160		
<b>Lot/Section/DP</b>	1	-	976423
<b>Heritage Study ID</b>	HS79		
<b>LEP ID</b>	Not currently included on the Cumberland LEP		
<b>Heritage Conservation Area</b>	Not included		
<b>Date Updated</b>	February 2021		
<b>Significance Level</b>	LOCAL		
<b>Site Type</b>	Level 1	Built	
	Level 2	Residential Buildings (private)

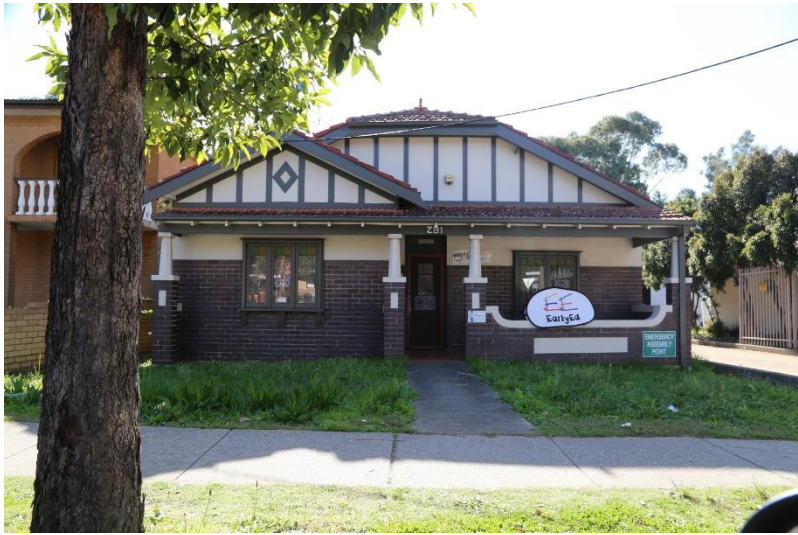
The house at 291 Merrylands Road is a single-storey, double fronted Federation Bungalow constructed of liver coloured brick with an early skillion extension to the rear. The main roof is a jerkinhead roof tiled in Marseilles tiles which with terracotta ridge capping. A forward-facing gable wing projects from the eastern side of the façade. Both roofs have timber barge boards, broad eaves and feature a rendered upper façade wall with half-timbered effect. The house has been recently painted to a new colour scheme.

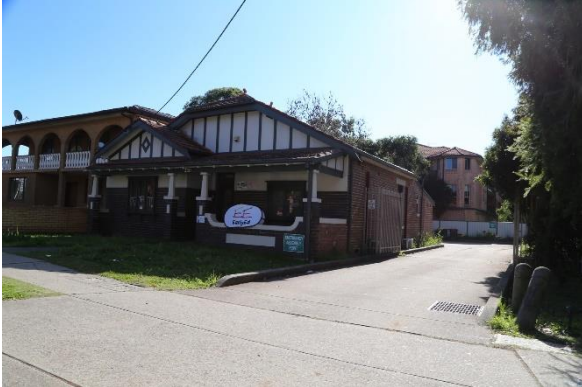
Overall, the cottage is in a good condition.

Overview of bungalow.

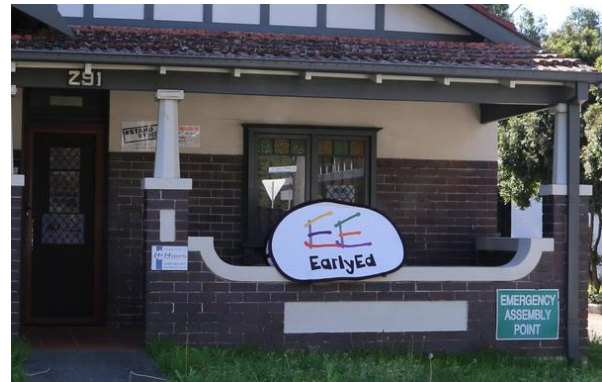
A skillion roofed verandah extends across the façade and is supported by tapered, faceted columns which are rendered and painted white, set atop face-brick piers. A curvilinear brick balustrade runs along the western end of the facade and features a horizontal rendered panel inset into the balustrade wall. The verandah features exposed timber eaves and a newly tiled floor.

Detail of verandah.
