Heritage Inventory Sheet

Recommended Name	Federation Bungalow		
Site Image

Address	214 Guildford Road, Guildford NSW 2161		
Lot/Section/DP	2	-	9694
Heritage Study ID	HS52		
LEP ID	Not currently included on the Cumberland LEP		
Heritage Conservation Area	Not included		
Date Updated	February 2021		
Significance Level	LOCAL		
Site Type	Level 1	Built	
	Level 2	Residential Buildings (private)

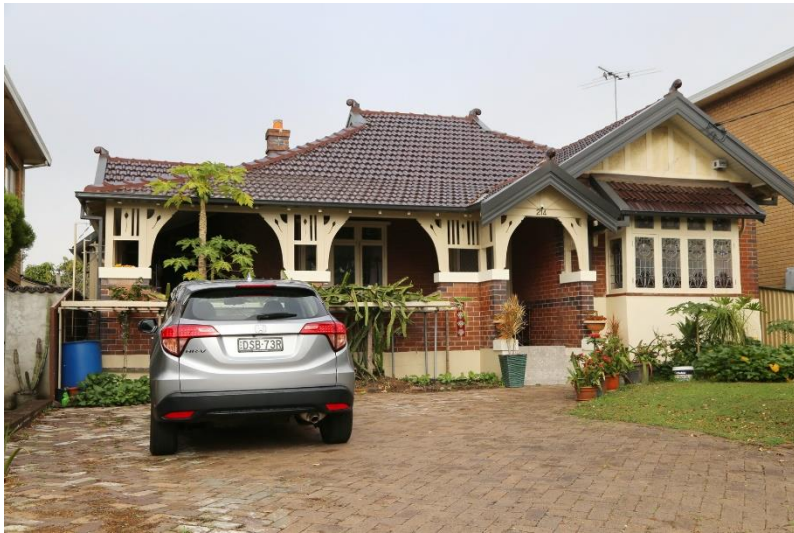
The house is a double fronted Federation bungalow with Queen Anne stylistic influences. The walls are constructed of polychromatic face-brick, laid in a stretcher bond and are supported on a rendered brick base. The house has a hipped roof with a projecting gable and gabled entrance porch. The roof is clad with terracotta tiles and terracotta ridge capping and decorative end pieces all glazed in a liver colour. The roof extends over a front verandah which returns towards the east elevation. There is one tall face-brick chimney that has expressed brick, stepped cornice and a terracotta cowl.

The house has been well-maintained and is considered to be in a good condition.

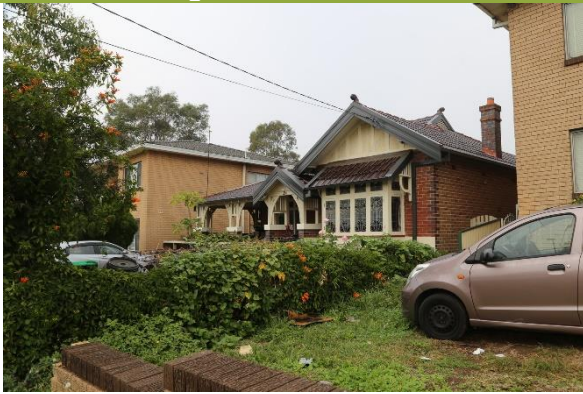
Overview of cottage.

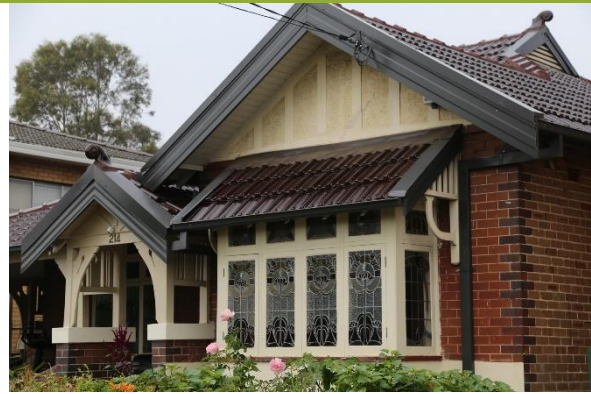
The gable end wall features a roughcast rendered upper gable with half-timbered effect, and a bay window with skillion hood clad in dark terracotta tiles. Each gable has timber barge boards that have been painted black. The lower wall of the gable beneath the window is rendered. The bay window consists of six timber framed casement windows with glazed stained-glass panes and fixed transom light.

Detail of projecting wing.

- Should the opportunity arise, a paint analysis should be undertaken and a more appropriate paint colour scheme should be implemented. The liver coloured glaze/paint used on the terracotta roof tiles and on the timber bargeboards is not sympathetic to the heritage values of the building.

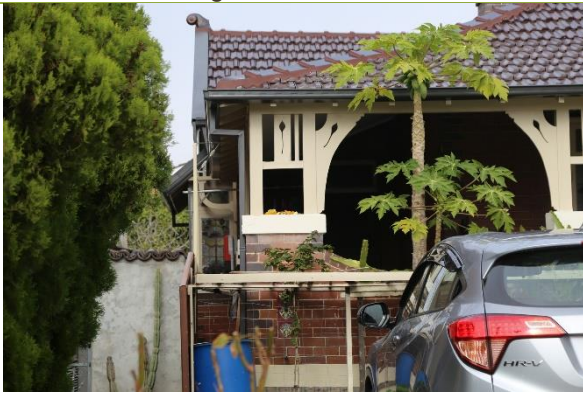
The front verandah features Art Nouveaux style timber brackets and timber posts painted white and set atop face brick piers with rendered coping. The verandah has a brick balustrade to which glazed tiles have been inset in a vertical arrangement in sets of four tiles. A central gabled porch provides access to the verandah via a set of modern stone steps between two rendered piers. The front door is obscured by a modern aluminium security screen. Adjacent to the door is a set of three timber framed casement windows with glazed stained-glass panes and fixed transom light. Along the side elevation there is another bay window, identical to the window on the façade.

Verandah.
