Heritage Inventory Sheet

Recommended Name	Post-War Austerity Style House		
Site Image

Address	38 Bolton Street, Guildford NSW 2161		
Lot/Section/DP	3	10	4047
Heritage Study ID	HS51		
LEP ID	Not currently included on the Cumberland LEP		
Heritage Conservation Area	Not included		
Date Updated	February 2021		
Significance Level	LOCAL		
Site Type	Level 1	Built	
	Level 2	Residential Buildings (private)

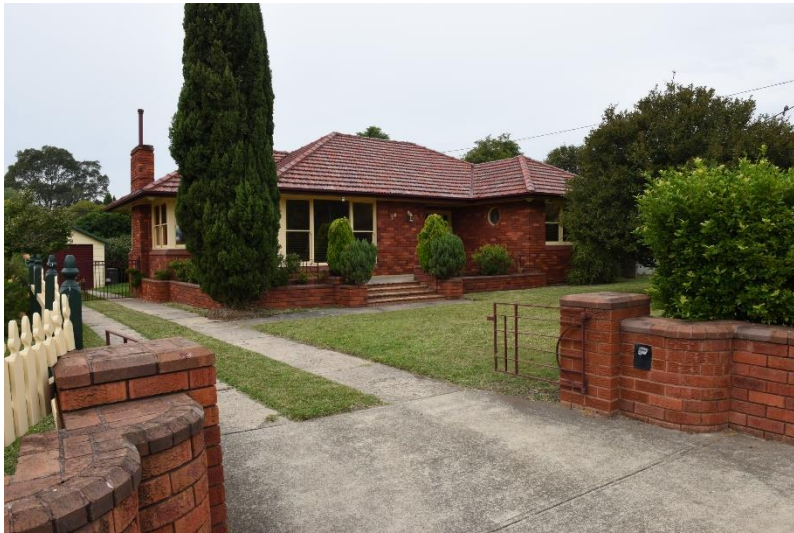
The house at 38 Bolton Street, Guildford is a good example of a late 1940s Post-War Austerity style house constructed of red brick, with modern influences. The hipped roof with a projecting hip to Bolton Street is tiled with Marseilles tiles and has Colorbond gutters and boxed eaves, and one large brick chimney. The windows on the front façade are timber double hung sashes, painted yellow. There is one bullseye window with a brick sill on the north elevation under the projecting hip. The front entrance is recessed and accessed via a porch. The porch is tiled with a metal balustrade of geometric design along the edge and is addressed by four brick steps. This is fronted by a brick retaining wall and garden bed. The garden bed has two dwarf conifers framing the steps, and one mature conifer northern corner of the garden bed.

The building is well maintained and in an excellent condition.

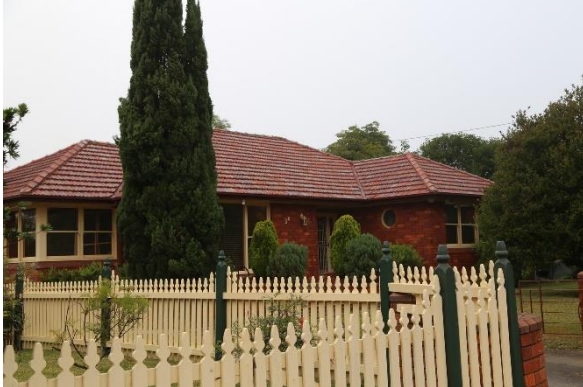
Overview of house, as viewed from Bolton Street.
